Paseo Community Development District

**Board of Supervisors' Meeting
July 22, 2020**

Barraco and Associates, serving as the District Engineer for the Paseo Community Development District (District), was requested to perform an overall site observation of specific District assets. This observation included review of the perimeter berm, concrete curb, roadway asphalt, brick paver and concrete sidewalks, roadway striping and signage, visible irrigation appurtenances, visible City of Fort Myers' water and sewer appurtenances for deficiencies and/ or required maintenance.

MAINTENANCE AND DEFICIENCIES NOTED

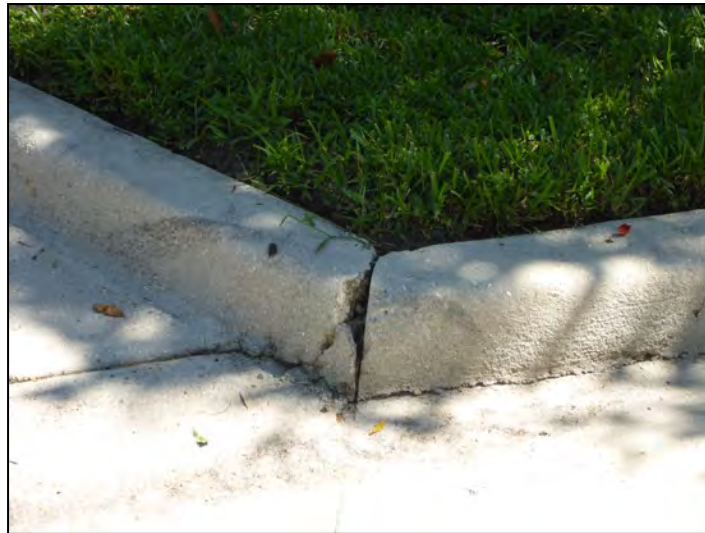
Picture 7 (P7)

Moderate fracture in type "F" curb with missing concrete.

Replace portion of curb.

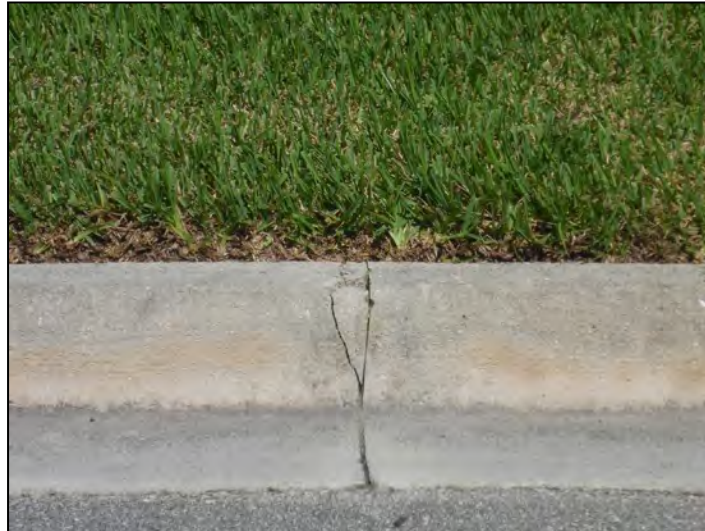
Picture 11 (P11)

Moderate fractures in type "F" curb.

Replace portion of curb.

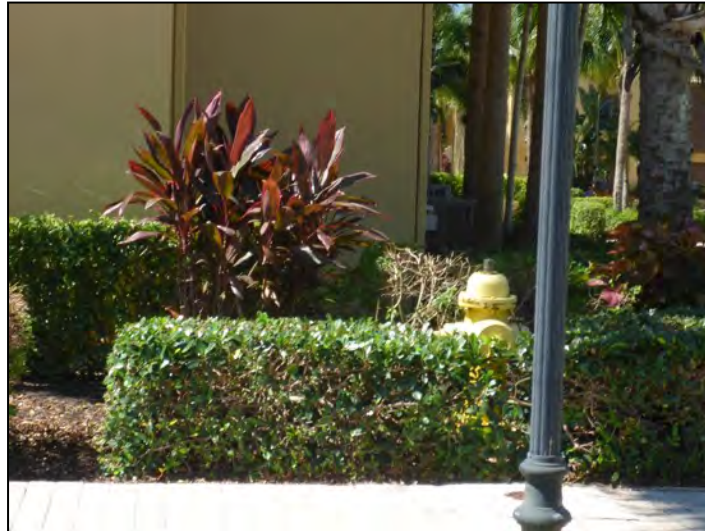
Picture 13 (P13)

Fire hydrant is obstructed by landscaping.

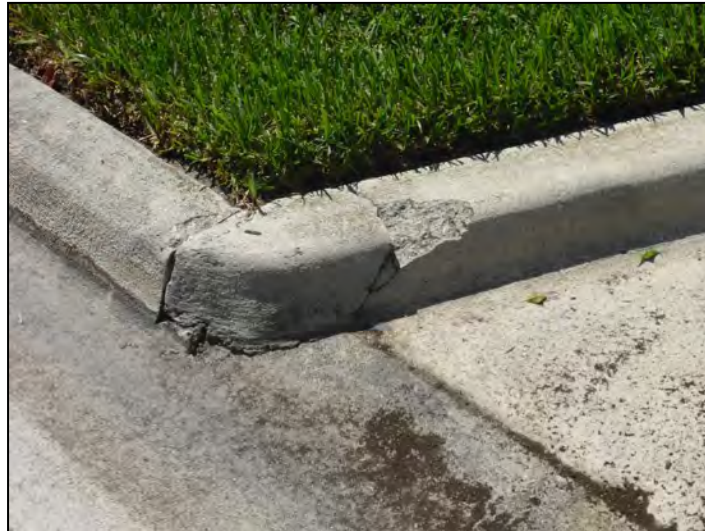
Picture 15 (P15)

Moderate fractures in type "F" curb with missing concrete pieces.

Replace portion of curb.

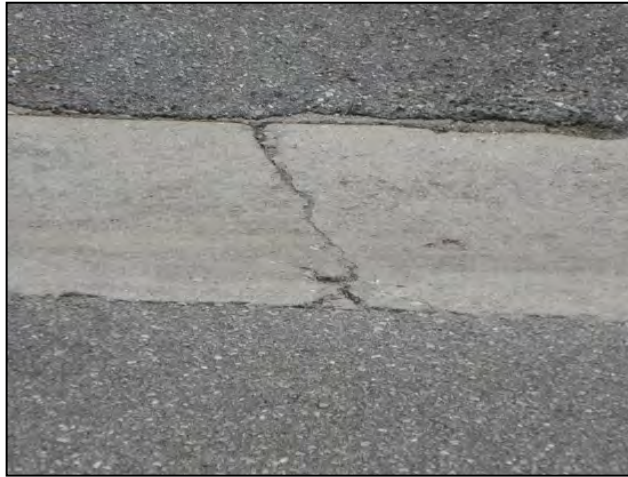
Picture 21 (P21)

Moderate fracture in valley gutter curb with missing concrete.

Replace portion of curb.

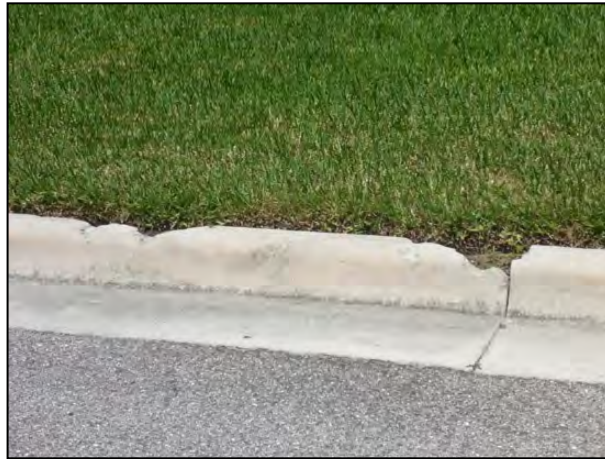
Picture 35 (P35)

Moderate fractures in the top of type "F" curb with missing concrete.

Replace portion of curb.

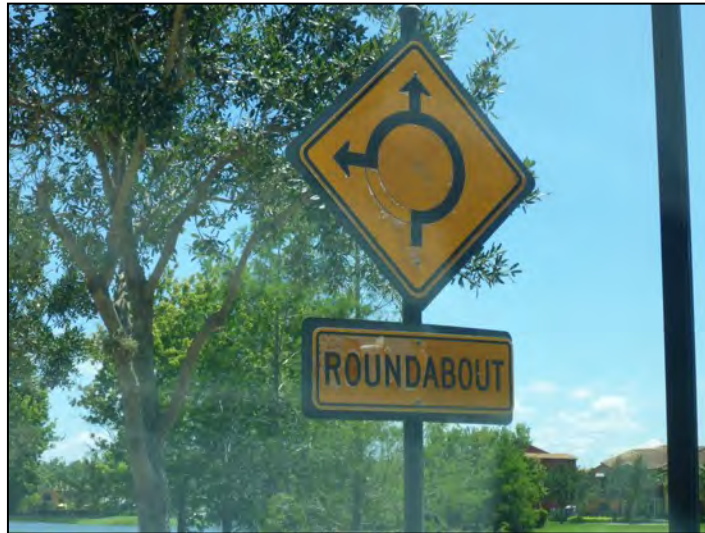
Picture 39 (P39)

Traffic sign is faded and peeling.

Replace traffic sign.

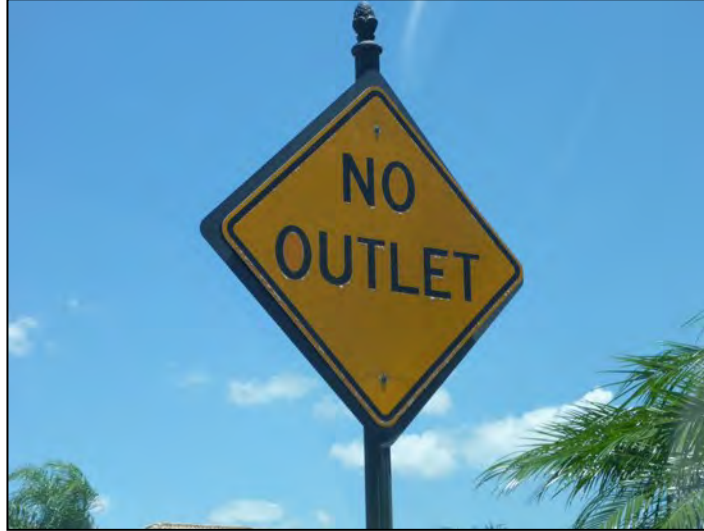
Picture 43 (P43)

Traffic sign is faded and peeling.

Replace traffic sign.

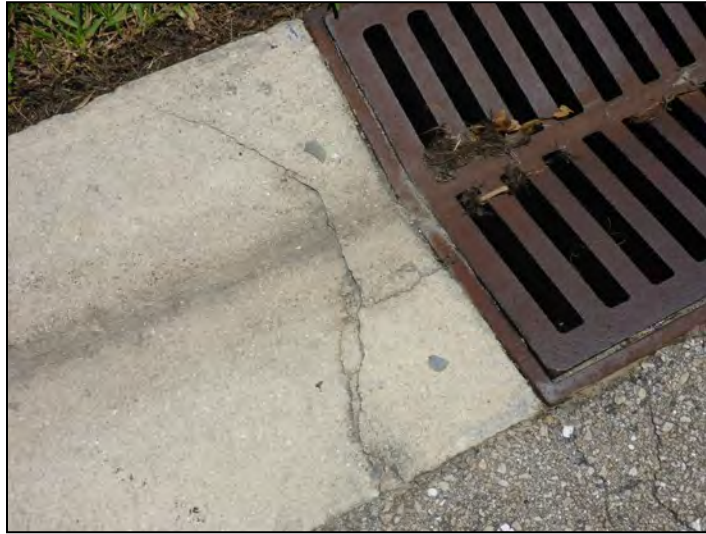
Picture 45 (P45)

Moderate fractures in valley gutter curb adjacent to inlet.

Replace portion of curb.

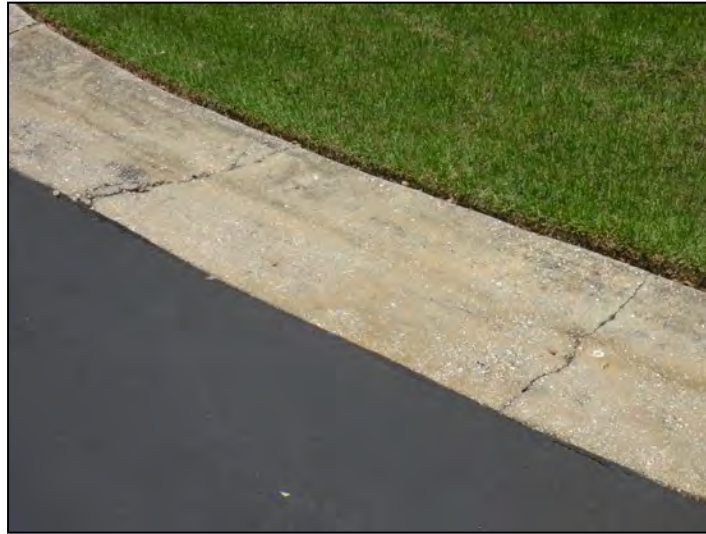
Picture 51 (P51)

Moderate fractures in valley gutter curb.

Replace portion of curb.

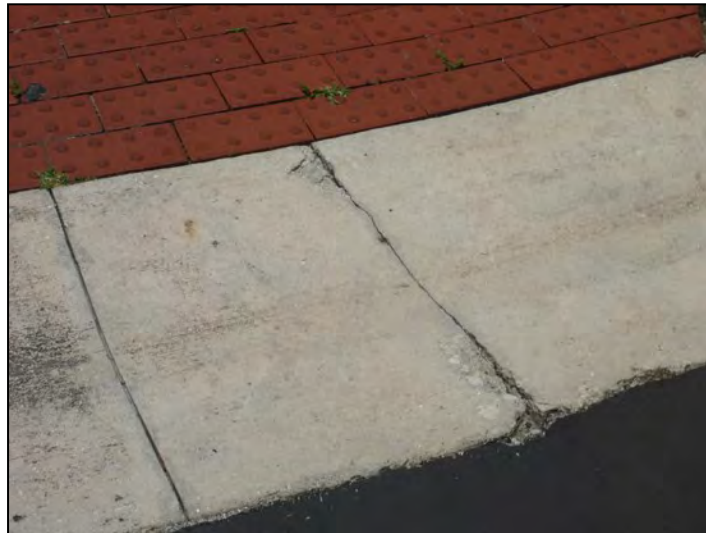
Picture 53 (P53)

Moderate fracture in valley gutter curb adjacent to detectable warning device.

Replace portion of curb.

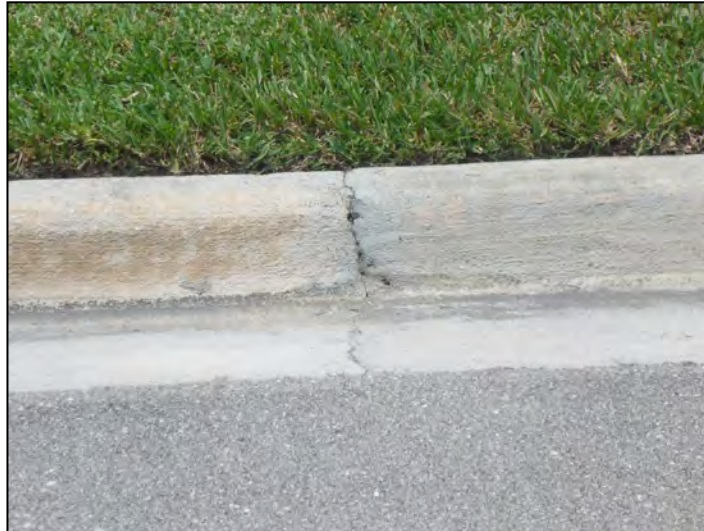
Picture 57 (P57)

Moderate fracture in type "F" curb.

Replace portion of curb.

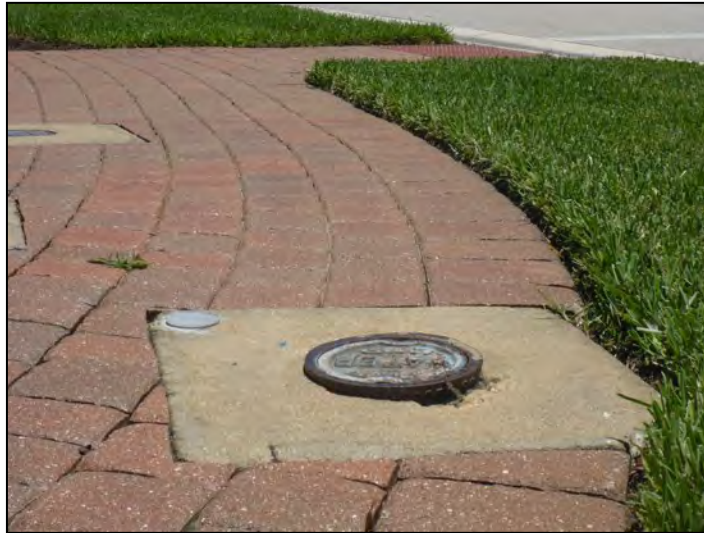
Picture 59 (P59)

Water valve ring and cover protruding from concrete base.

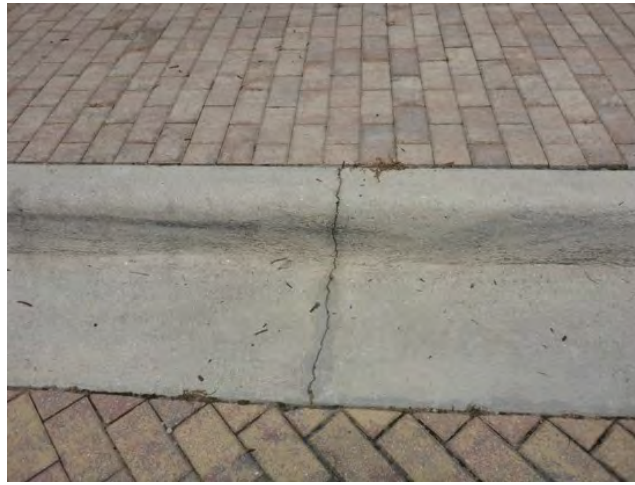
Picture 67 (P67)

Moderate fracture in type "F" curb.

Replace portion of curb.

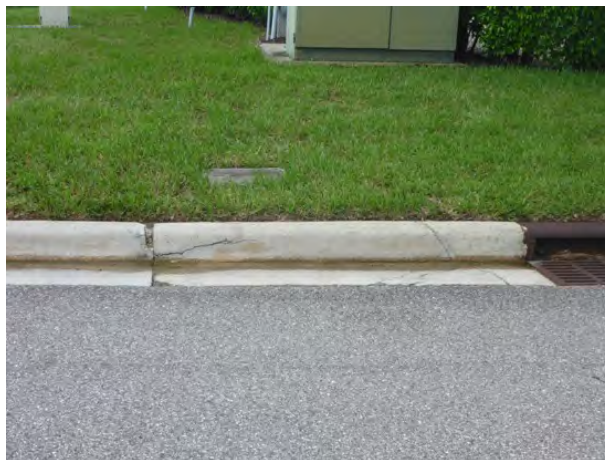
Picture 68 (P68)

Moderate fractures in type "F" curb adjacent to inlet with missing concrete pieces.

Replace portion of curb.

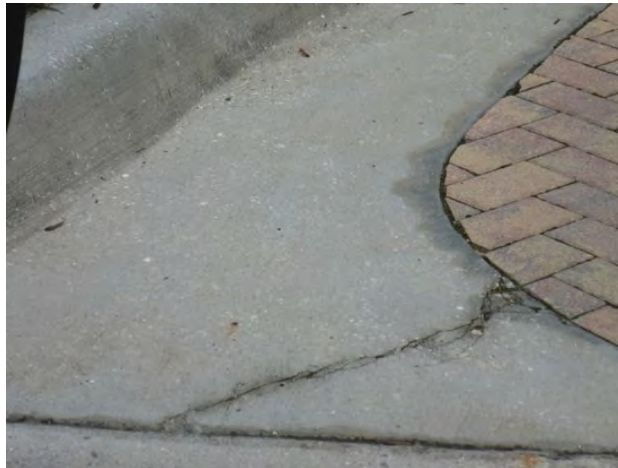
Picture 69 (P69)

Moderate fracture in type "F" curb.

Replace portion of curb.

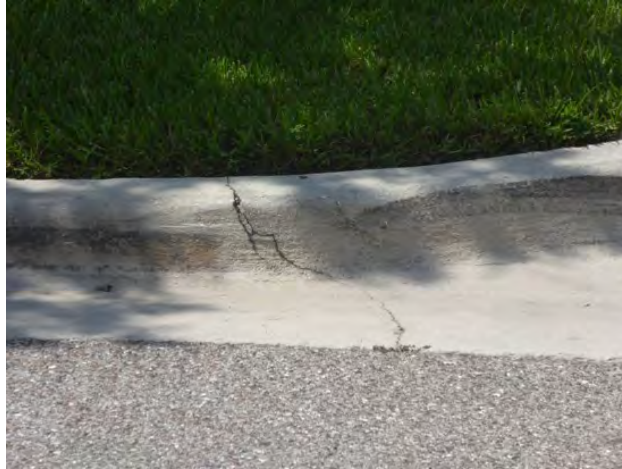
Picture 71 (P71)

Moderate fractures in type "F" curb.

Replace portion of curb.

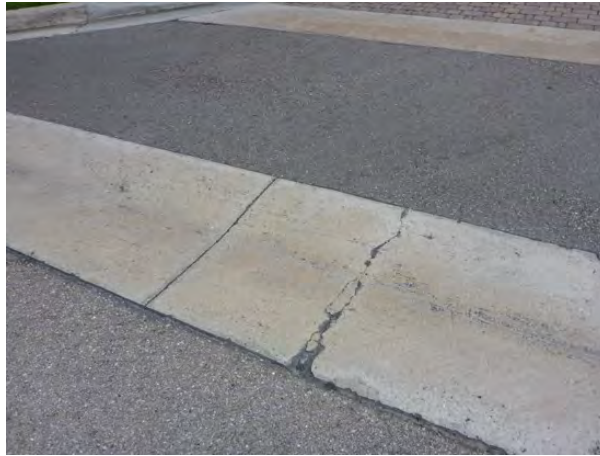
Picture 75 (P75)

Moderate fracture in valley gutter curb with missing concrete.

Replace portion of curb.

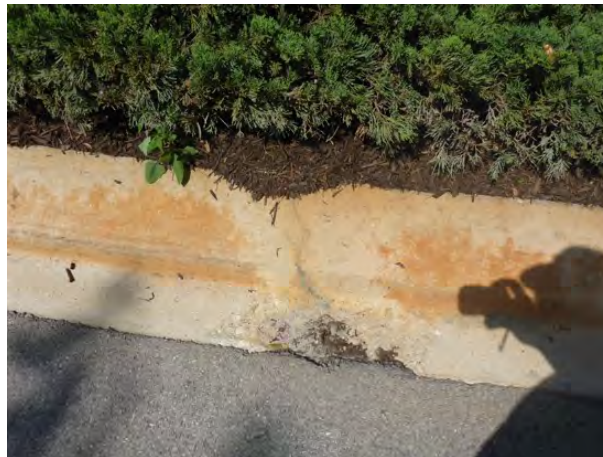
Picture 80 (P80)

Moderate fracture in valley gutter curb with missing concrete.

Replace portion of curb.

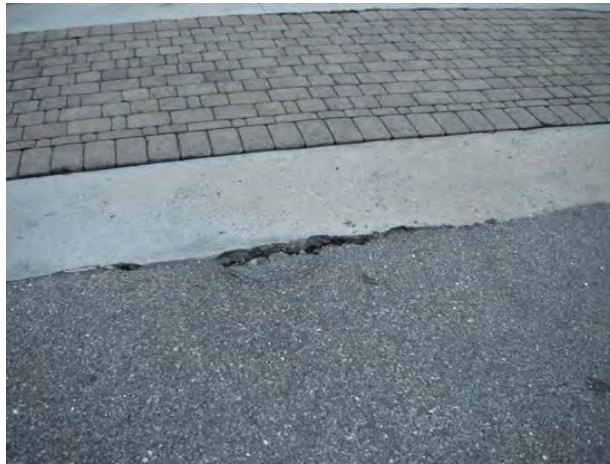
Picture 81 (P81)

Pavement settling at ribbon curb.

Patch or mill and resurface pavement.

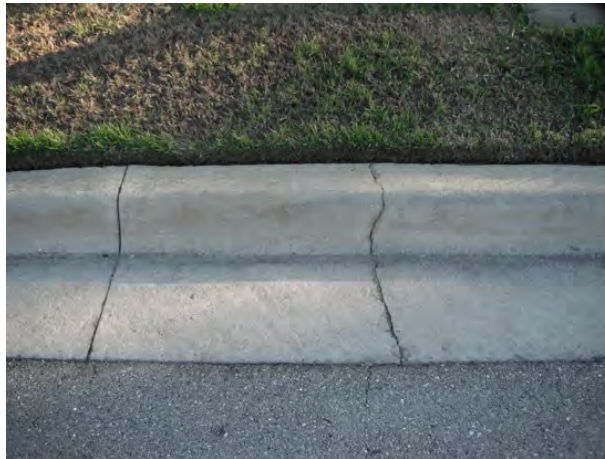
Picture 82 (P82)

Moderate fracture in type "F" curb.

Replace portion of curb.

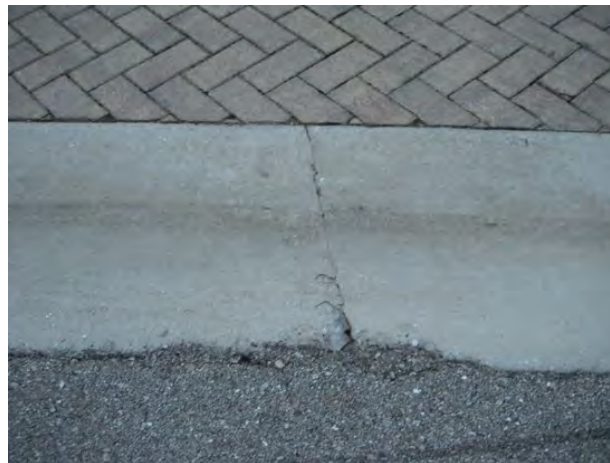
Picture 84 (P84)

Moderate fracture in type "F" curb with missing concrete.

Replace portion of curb.

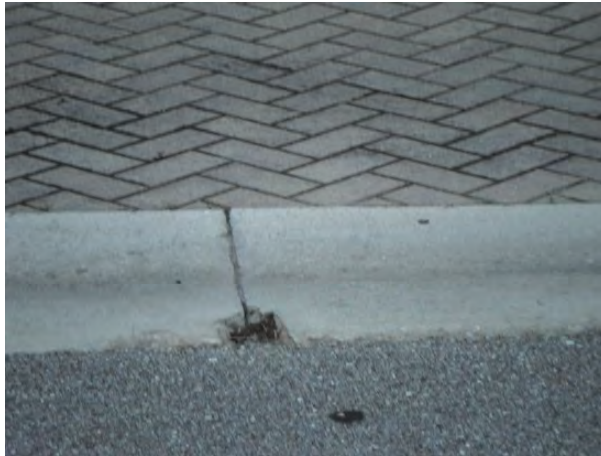
Picture 85 (P85)

Moderate fracture in type "F" curb with missing concrete.

Replace portion of curb.

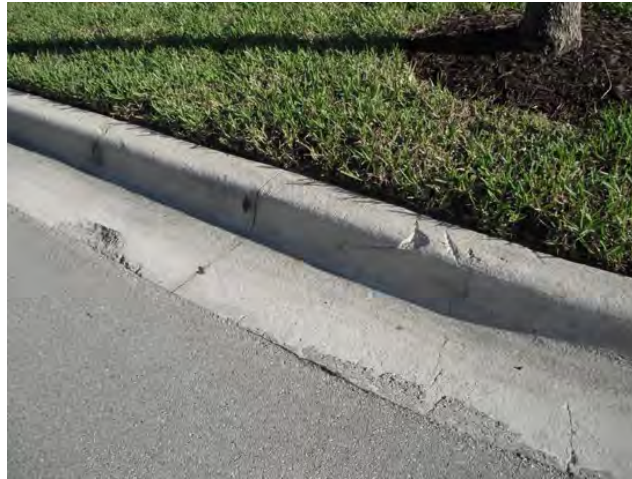
Picture 87 (P87)

Moderate fractures in type "F" curb with missing concrete.

Replace portion of curb.

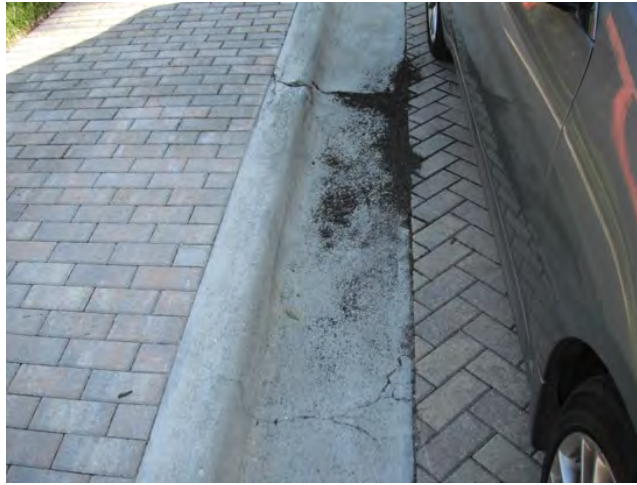
Picture 91 (P91)

Moderate fractures in type "F" curb with missing concrete.

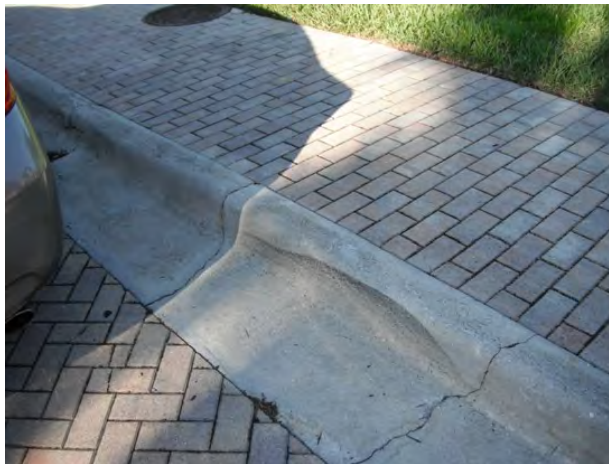
Picture 92 (P92)

Moderate fracture in type "F" curb.

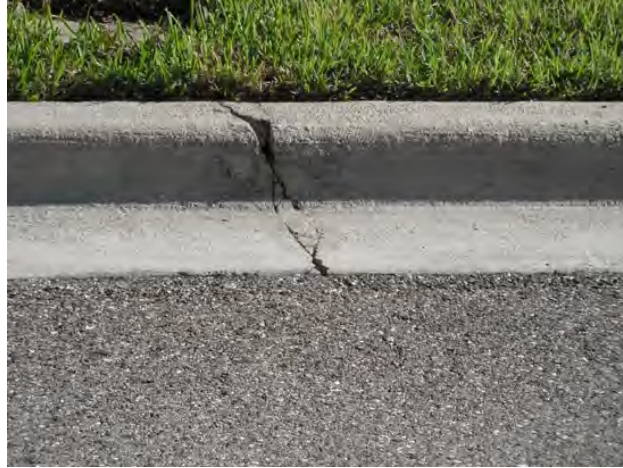
Picture 93 (P93)

Moderate fractures in type "F" curb with missing concrete.

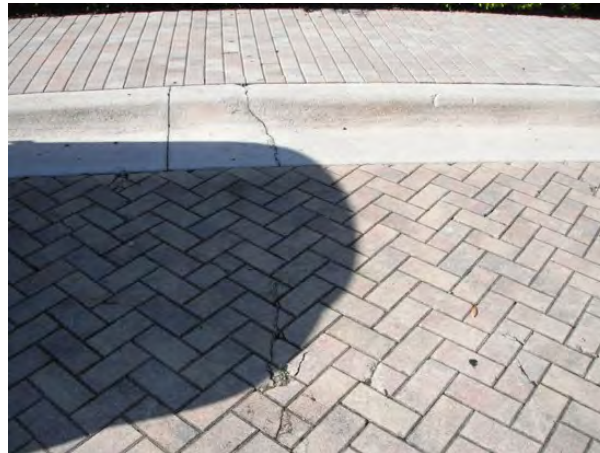
Picture 94 (P94)

Moderate fracture in type "F" curb and paver bricks.

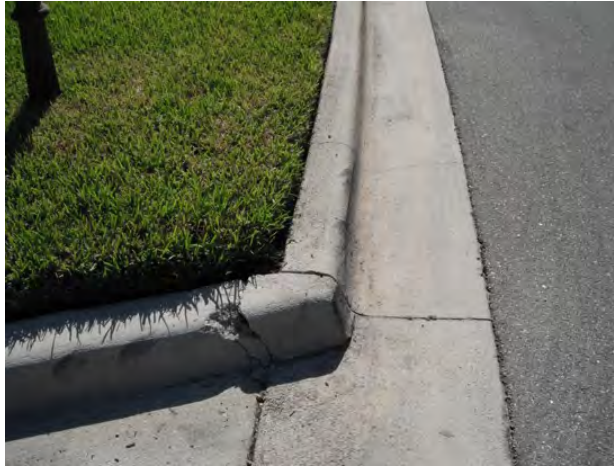
Picture 97 (P97)

Moderate fractures in type "F" curb with missing concrete.

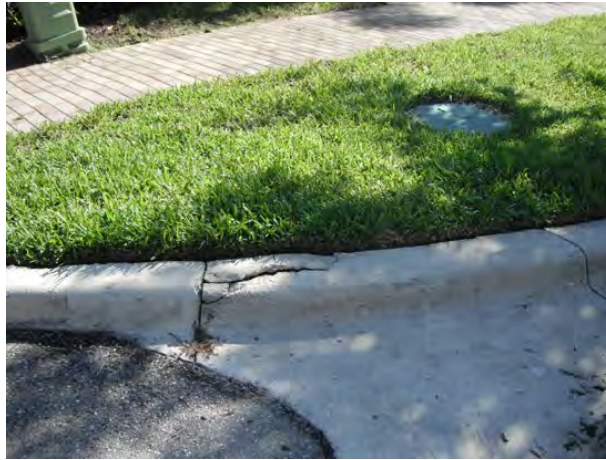
Picture 99 (P99)

Moderate fractures in type "F" curb with loose concrete pieces.

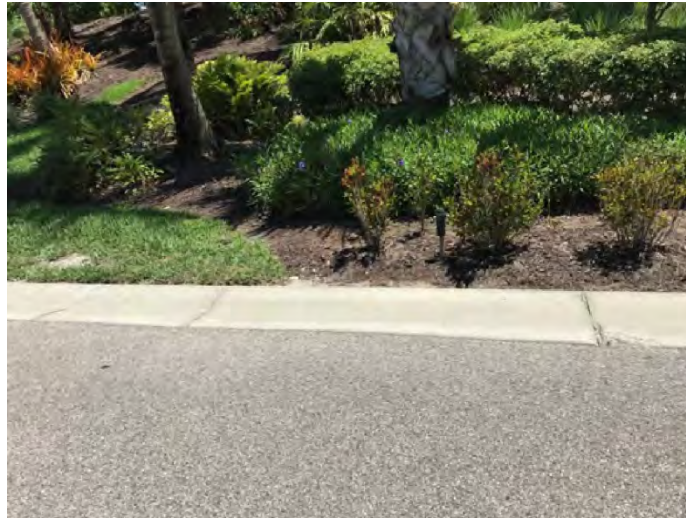
Picture 101 (P101)

Moderate fracture in valley gutter curb with missing concrete.

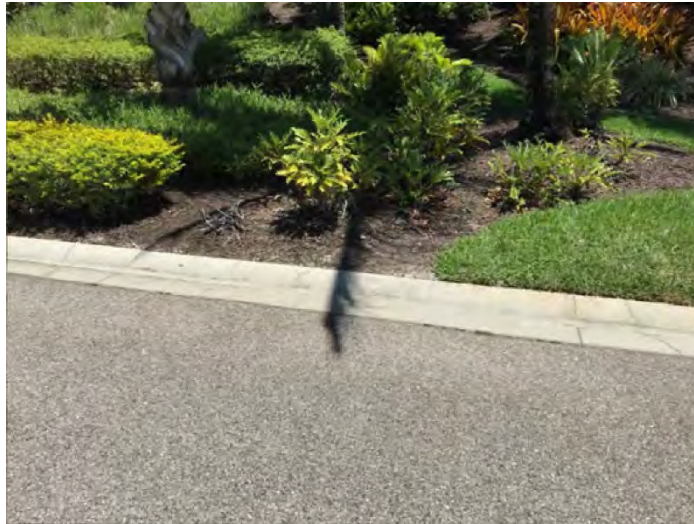
Picture 103 (P103)

Multiple moderate fractures in valley gutter curb.

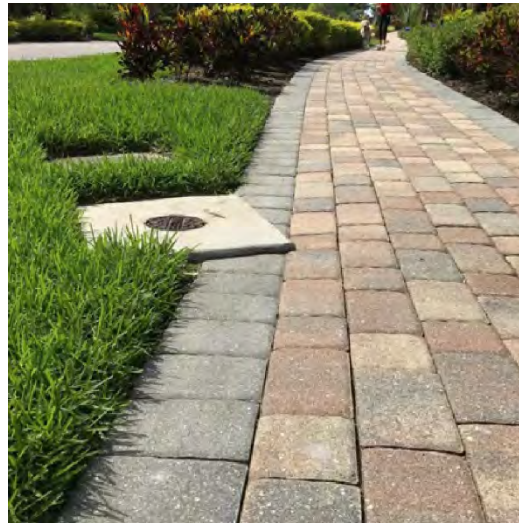
Picture 105 (P105)

Paver bricks settling around concrete valve pad creating tripping hazard.

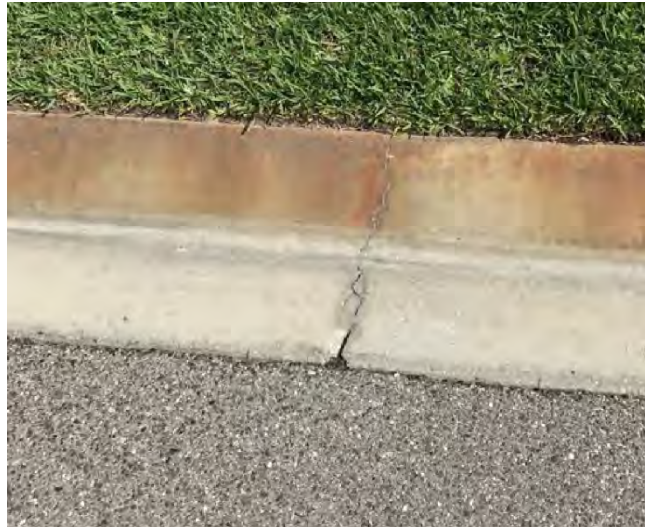
Picture 117 (P117)

Moderate fracture in valley gutter curb with loose missing concrete.

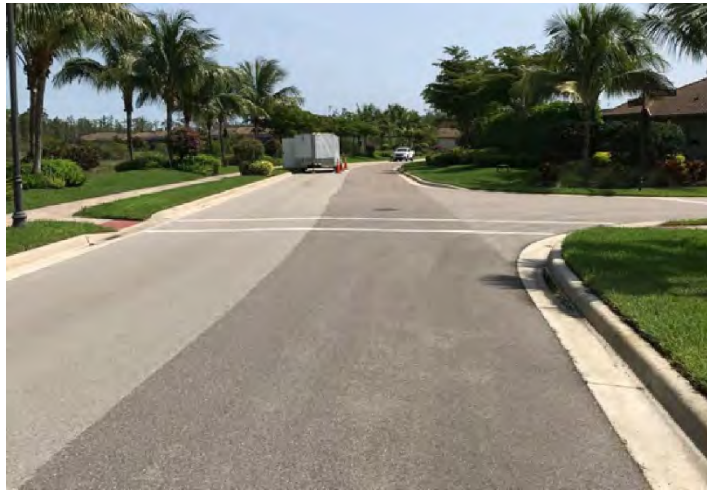
Picture 119 (P119)

Description:
Crosswalk signage missing.

Recommended Action:
Consider installing midblock crossing signage throughout.

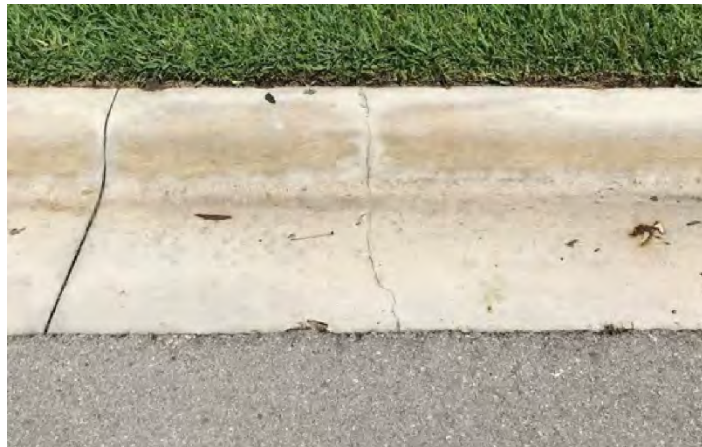
Picture 120 (P120)

Description:
Moderate fracture in type "F" curb with missing concrete.

Recommended Action:
Replace portion of curb.

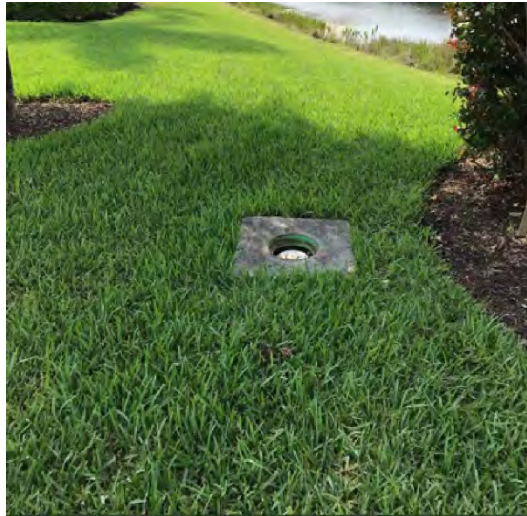
Picture 121 (P121)

Sanitary service valve missing lid.

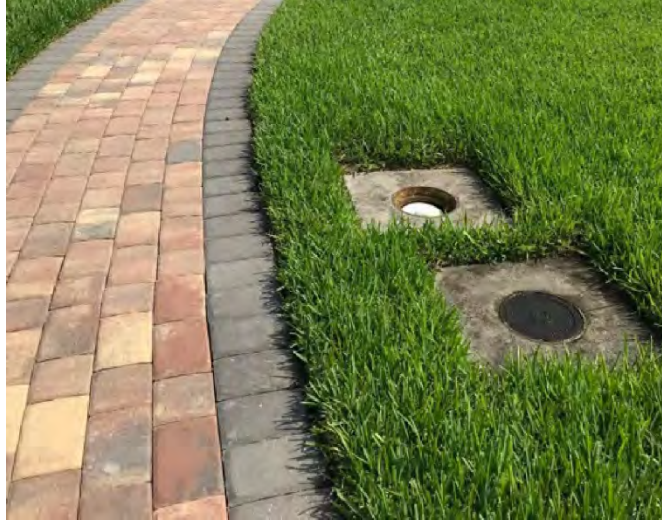
Picture 127 (P127)

Description:
Sanitary service valve missing lid.

Recommended Action:
Notify City of Fort Myers Utilities department.

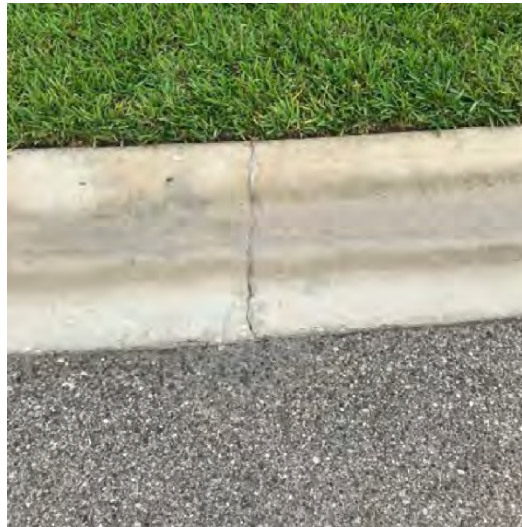
Picture 139 (P139)

Moderate fracture in valley gutter curb.

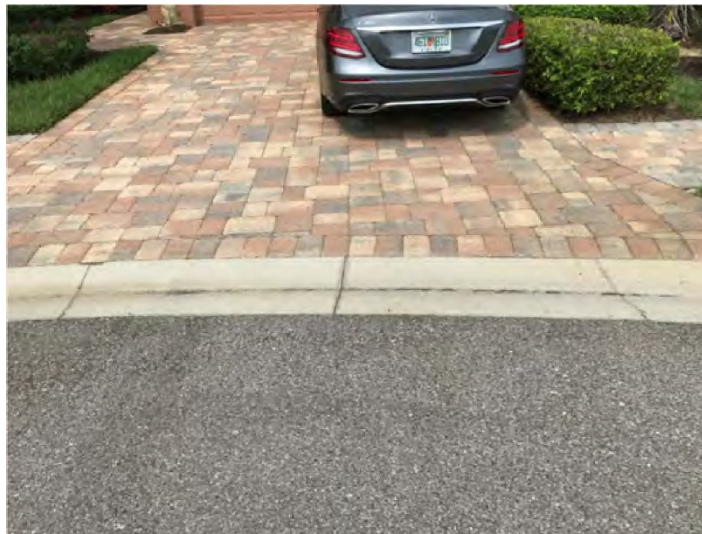
Picture 143 (P143)

Moderate fractures in valley gutter curb.

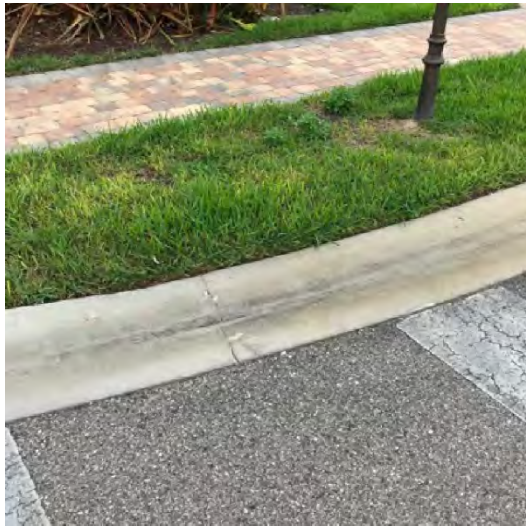
Picture 145 (P145)

Moderate fracture in valley gutter curb with missing concrete.

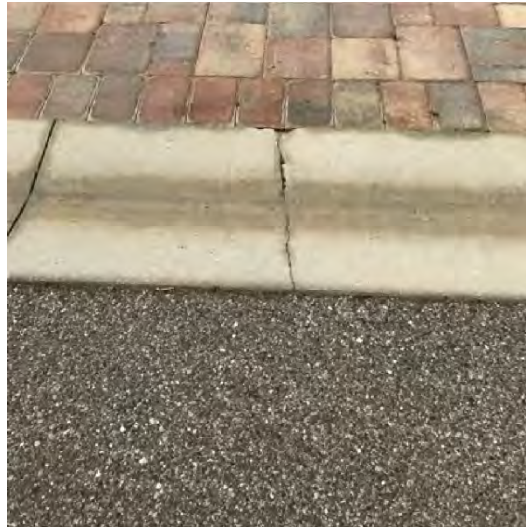
Picture 147 (P147)

Moderate fracture in valley gutter curb.

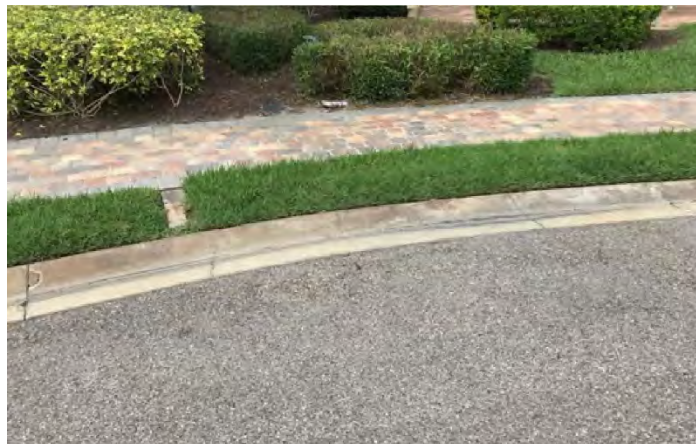
Picture 150 (P150)

Multiple moderate fractures in valley gutter curb with missing and loose concrete pieces.

Replace portion of curb.

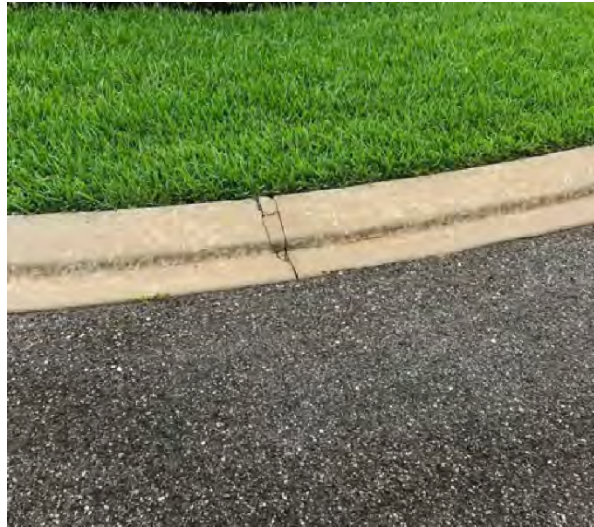
Picture 151 (P151)

Moderate fracture in type "A" curb with loose concrete pieces.

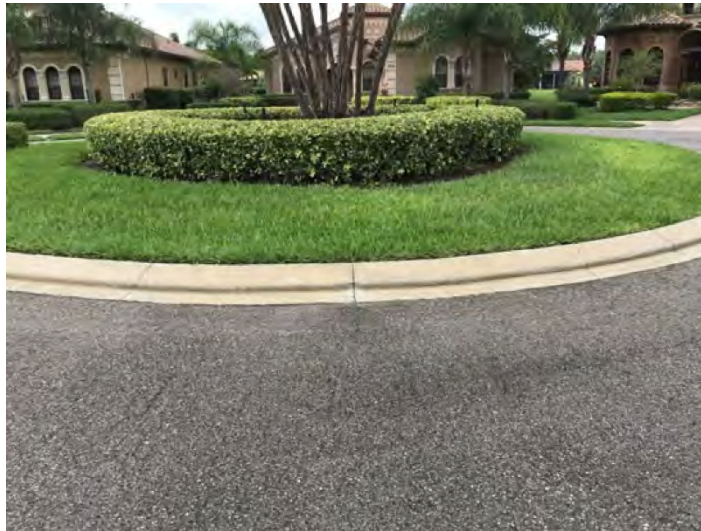
Picture 153 (P153)

Multiple moderate fractures in type "A" curb.

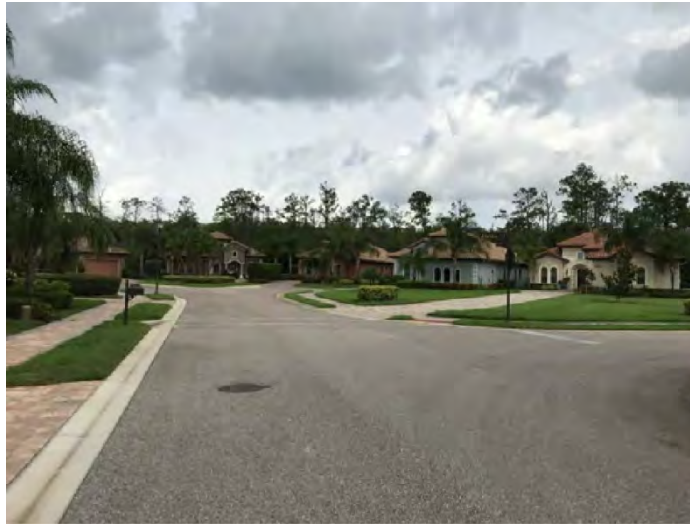
Picture 155 (P155)

Stop bar and crosswalk striping faded with missing crosswalk signage.

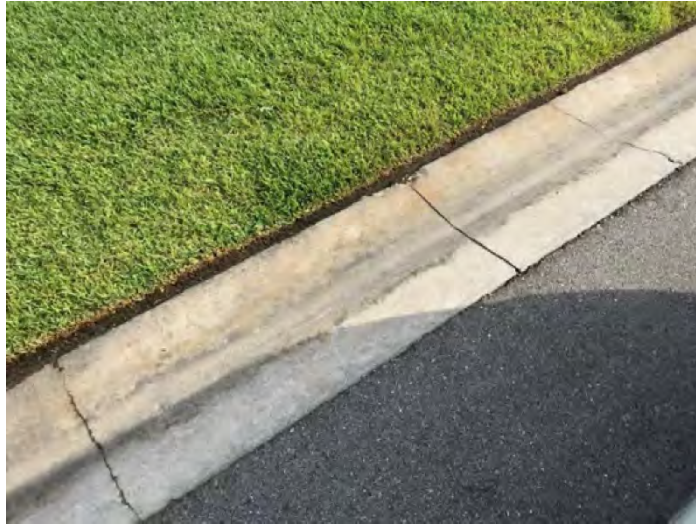
Picture 177 (P177)

Moderate fractures in valley gutter curb.

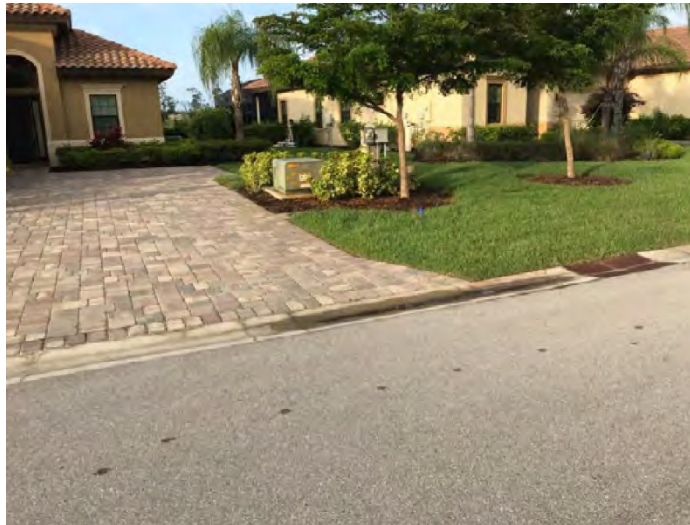
Picture 209 (P209)

Multiple moderate fractures in valley gutter curb adjacent to inlet.

Replace portion of curb.

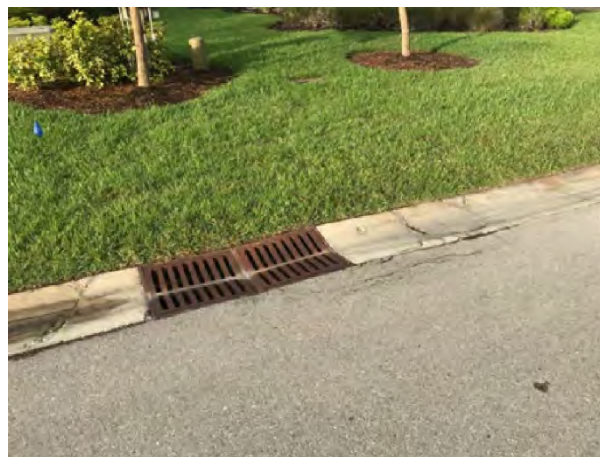
Picture 210 (P210)

Multiple moderate fractures in valley gutter curb adjacent to inlet with missing concrete.

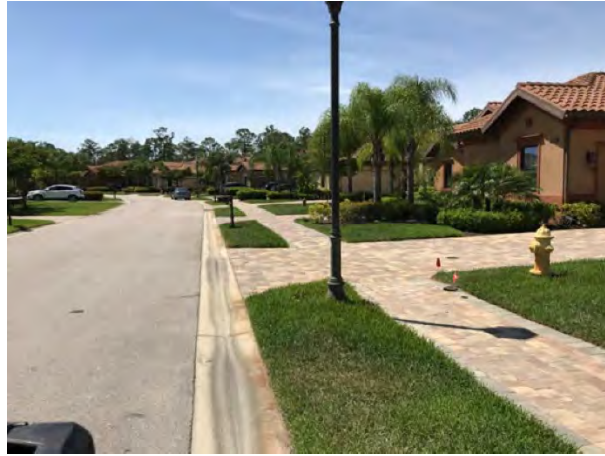
Picture 213 (P213)

Fire hydrant missing road pavement marker and the water valve ring and cover protruding from paver bricks creating tripping hazard.

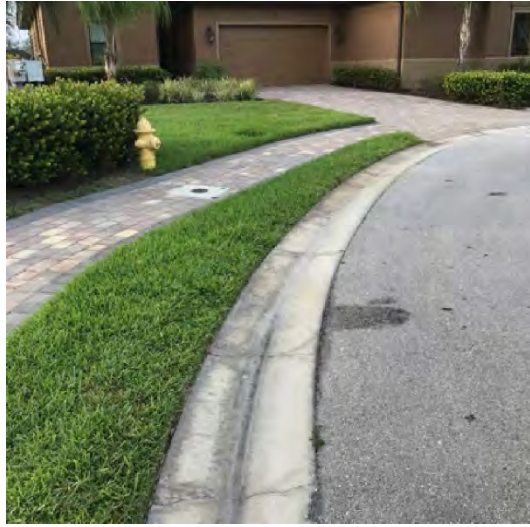
Picture 219 (P219)

Moderate fractures in valley gutter curb with loose concrete pieces, fire hydrant missing road pavement marker, and water valve missing lid.

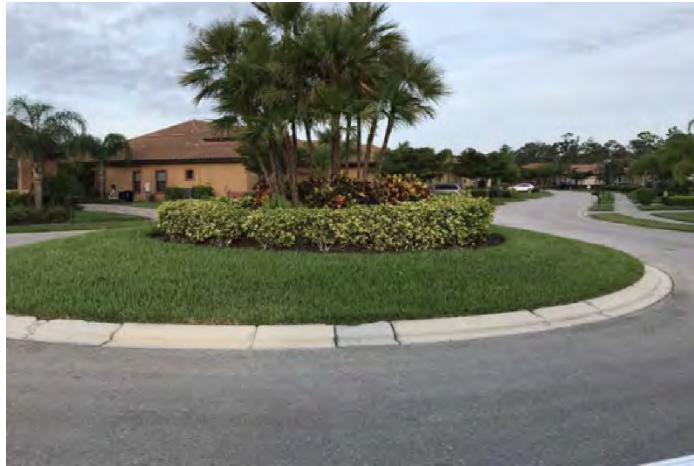
Picture 221 (P221)

Moderate fractures in type "A" curb with substantial missing concrete.

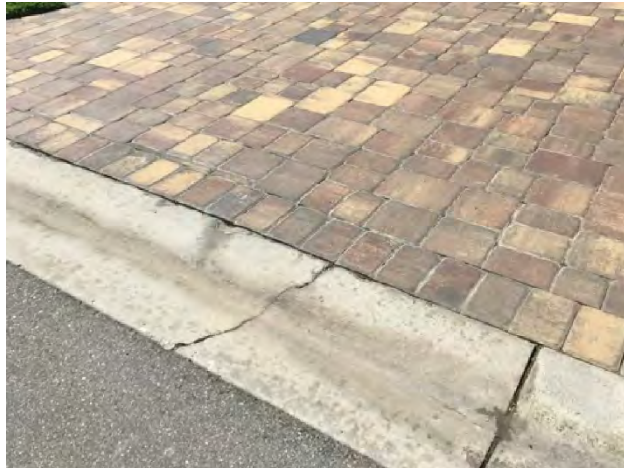
Picture 225 (P225)

Description:
Moderate fracture in valley gutter curb.

Recommended Action:
Replace portion of curb.

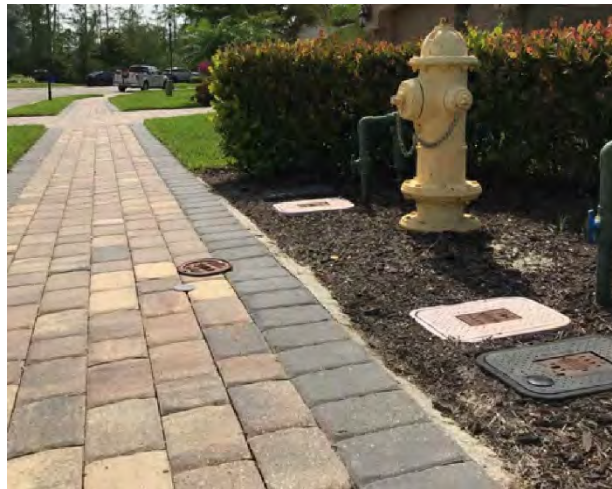
Picture 230 (P230)

Water valve ring and cover protruding from paver bricks creating tripping hazard.

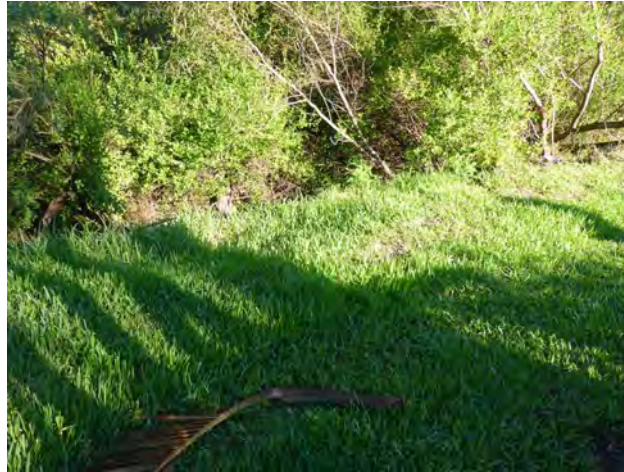
Picture 233 (P233)

Berm is eroded and potentially breached.

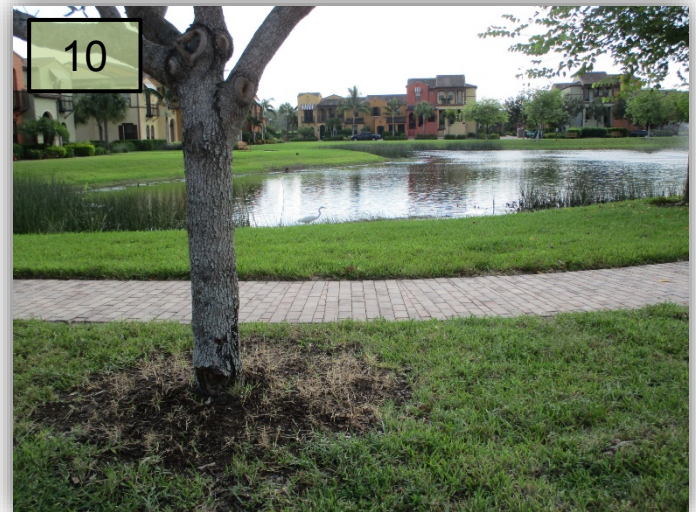
10. We need to keep tree rings looking better than this one. (Pic 10)

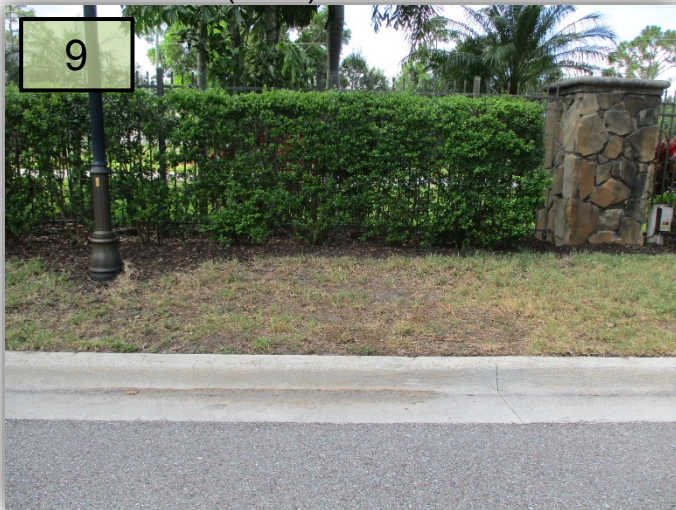
9. There are also areas of turf (perhaps being shaded out as it is on the north side of a tall landscape buffer along Penzance) in poor condition along the southern leg of Palba. Perhaps a shade tolerant variety of St. Augustine (Bitter Blue) might work better in these areas. (Pic 9)

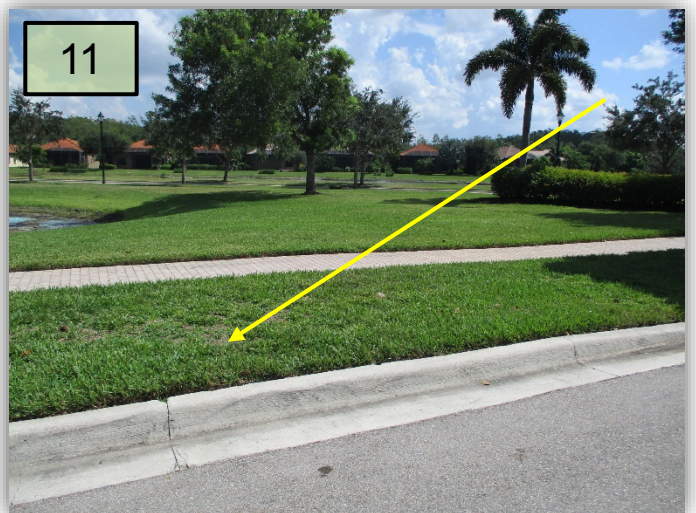
11. Another problem spot of turf is at Izarra turning south at the eastern corner of the pond. Is this chinch bug activity? (Pic 11)

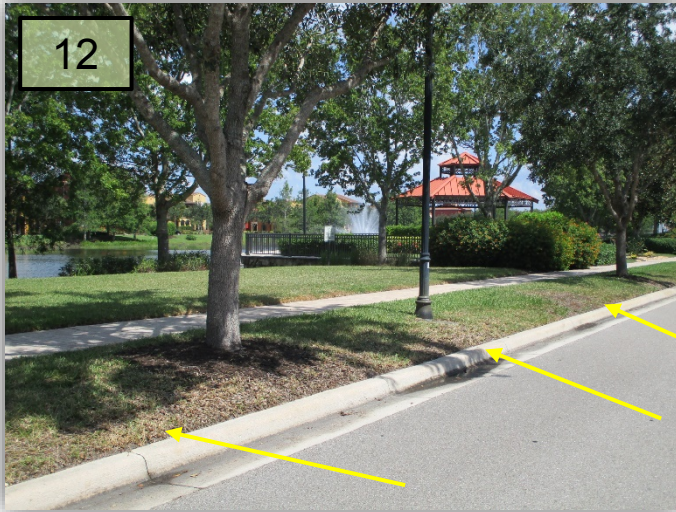
12. Damage to the turf on the east side of Paseo Grande in the southern portion ROW resembles chinch bug damage as it seems to originate at the curb line and work its way inward. Has this been diagnosed and treated? (Pic 12)

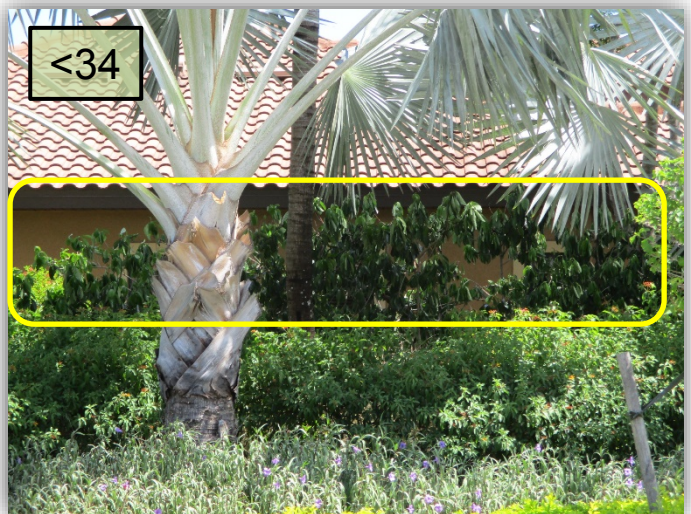
34. A Viburnum hedge at the rear of the landscape buffer on the NW corner of the intersection of Esteban and Paseo Dr. is in very severe wilt. In fact, there may be cellular damage to leaves which may not recover. An update from Pinnacle informed me that a GFI tripped the previous week and has been re-set. Also a couple decoders were in the process of being replaced. Run days and times have been increased to provide more water through the weekend. (Pic 34>)

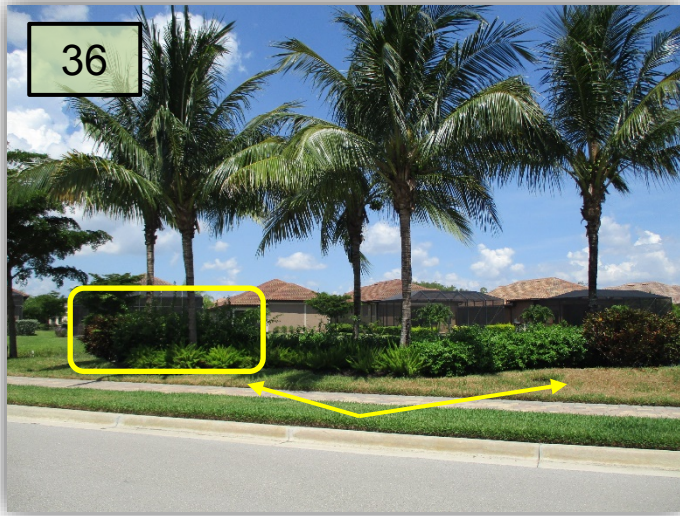
36. Across the street from the Falisto entrance, more turf is extremely dry and the Golden Dewdrop is out of control. (Pic 36)
