Paseo Community Development District

**Board of Supervisors' Meeting
July 22, 2020**

Barraco and Associates, serving as the District Engineer for the Paseo Community Development District (District), was requested to perform an overall site observation of specific District assets. This observation included review of the perimeter berm, concrete curb, roadway asphalt, brick paver and concrete sidewalks, roadway striping and signage, visible irrigation appurtenances, visible City of Fort Myers' water and sewer appurtenances for deficiencies and/ or required maintenance.

MAINTENANCE AND DEFICIENCIES NOTED

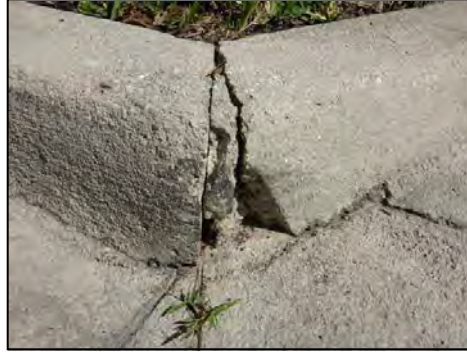
Picture 1 (P1)

Moderate fracture in type "F" curb with missing concrete.

Replace section of curb.

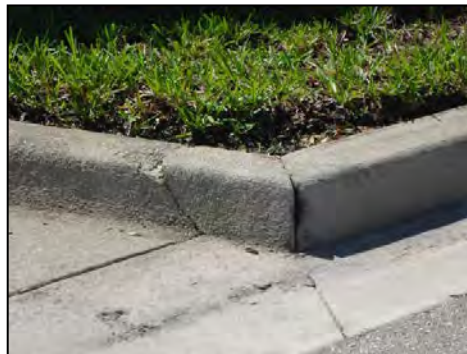
Picture 2 (P2)

Moderate fractures in type "F" curb with missing concrete.

Replace section of curb.

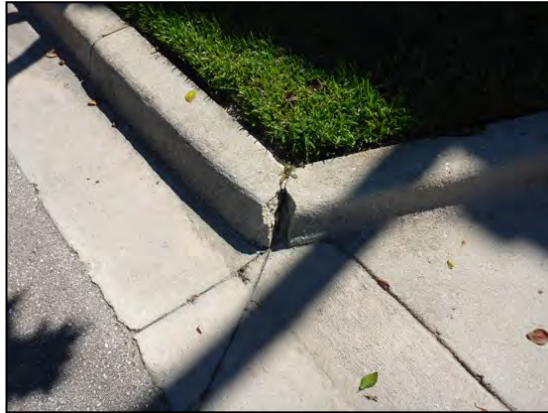
Picture 3 (P3)

Moderate fracture in type "F" curb with missing concrete.

Replace section of curb.

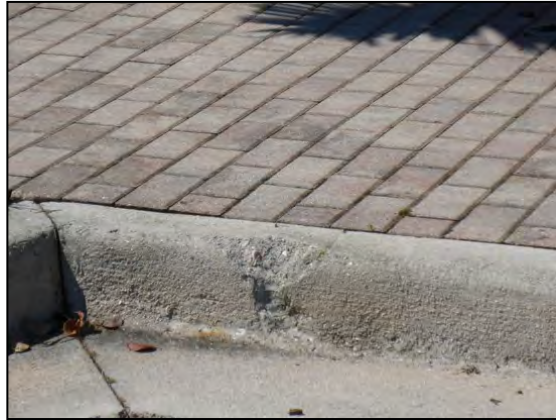
Picture 5 (P5)

Type "F" curb with missing piece.

Repair missing curb.

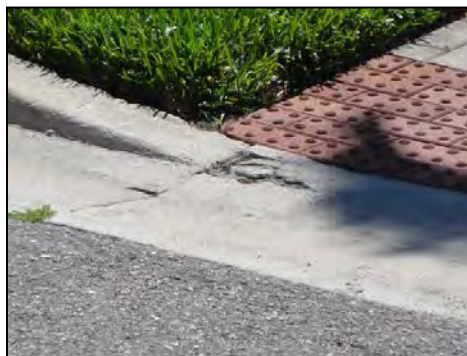
Picture 8 (P8)

Moderate fracture in valley gutter curb adjacent to detectable warning device.

Repair valley gutter curb.

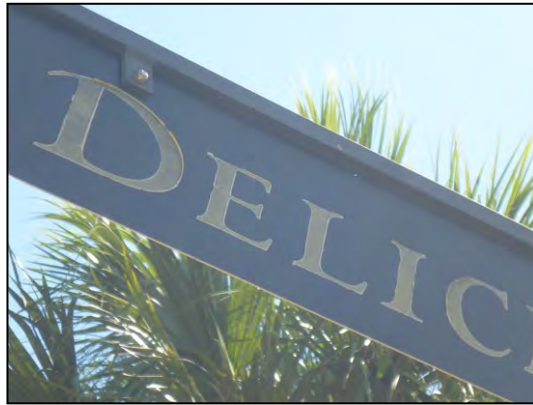
Picture 9 (P9)

Street sign is faded and peeling.

Replace street sign.

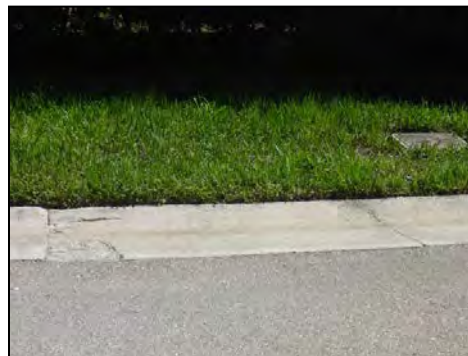
Picture 12 (P12)

Moderate fractures and missing concrete in valley gutter curb.

Replace portion of curb.

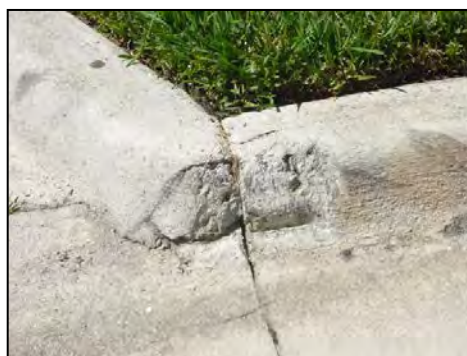
Picture 14 (P14)

Type "F" curb broken with missing concrete pieces.

Repair/replace portion of curb.

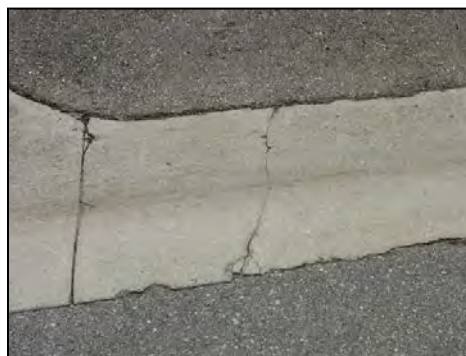
Picture 16 (P16)

Moderate fracture in valley gutter curb.

Replace portion of curb.

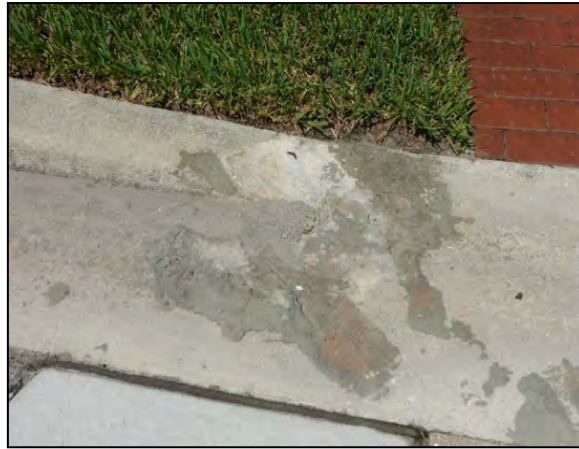
Picture 17 (P17)

Excess concrete remnants at curb transition.

Remove excess concrete remnants.

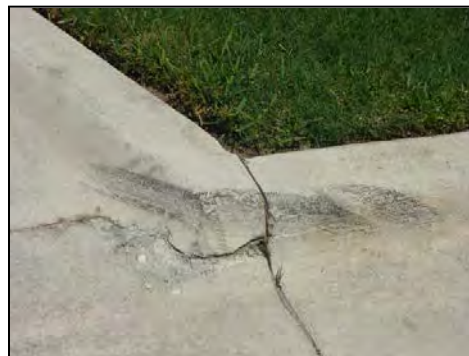
Picture 18 (P18)

Moderate fracture in type "F" curb with missing concrete.

Replace portion of curb.

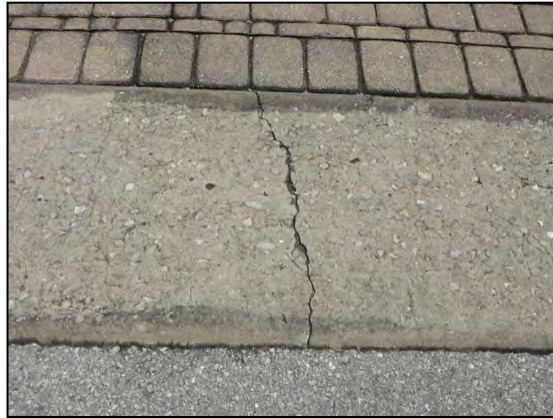
Picture 19 (P19)

Moderate fracture in ribbon curb at crosswalk.

Replace portion of curb.

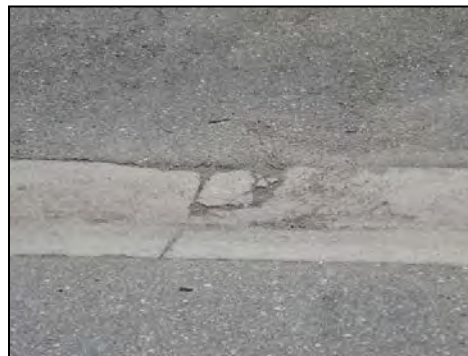
Picture 20 (P20)

Moderate fractures in valley gutter curb.

Replace portion of curb.

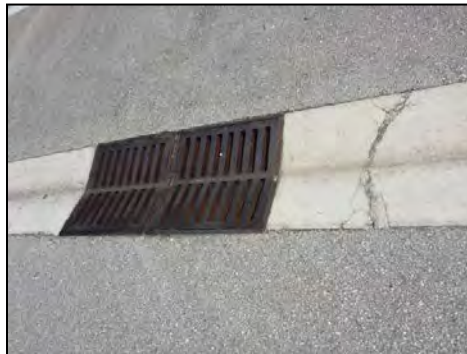
Picture 22 (P22)

Moderate fractures in valley gutter curb adjacent to inlet.

Replace portion of curb.

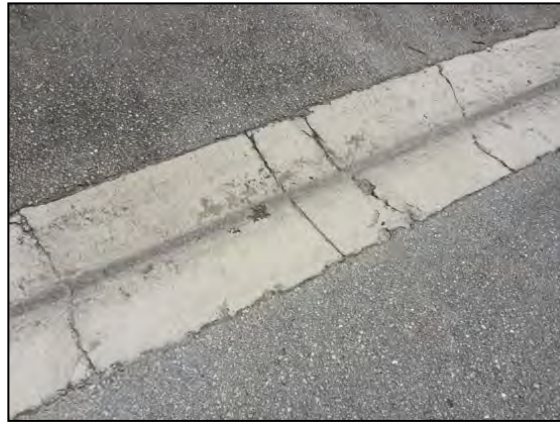
Picture 23 (P23)

Multiple fractures in valley gutter curb.

Replace portion of curb.

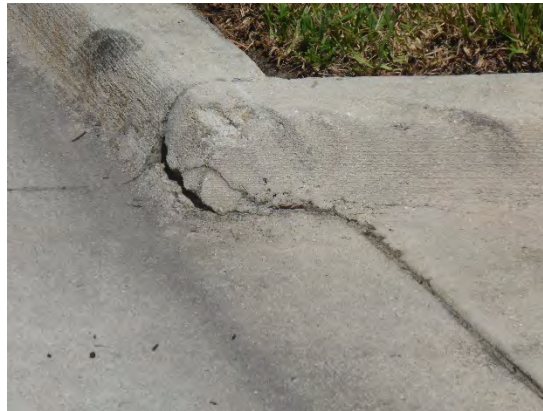
Picture 24 (P24)

Multiple fractures in type "F" curb.

Replace/repair portion of curb.

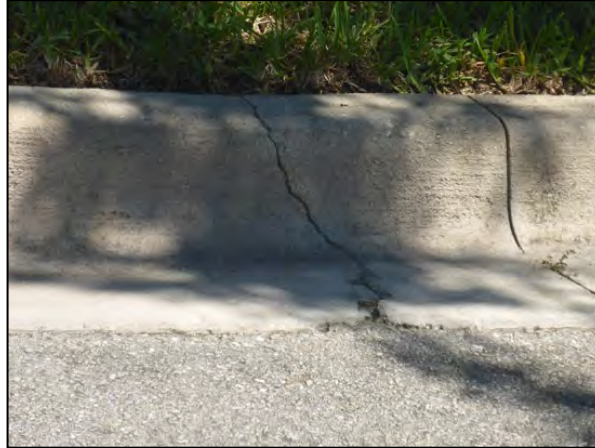
Picture 25 (P25)

Moderate fracture in type "F" curb.

Replace portion of curb.

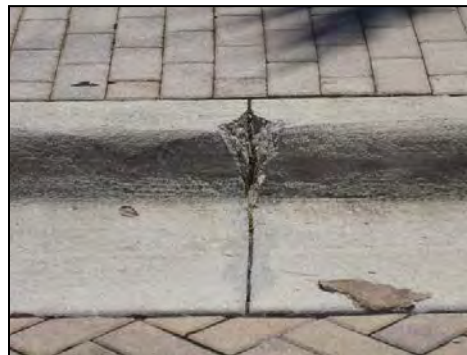
Picture 26 (P26)

Moderate fracture in type "F" curb with missing concrete.

Replace portion of curb.

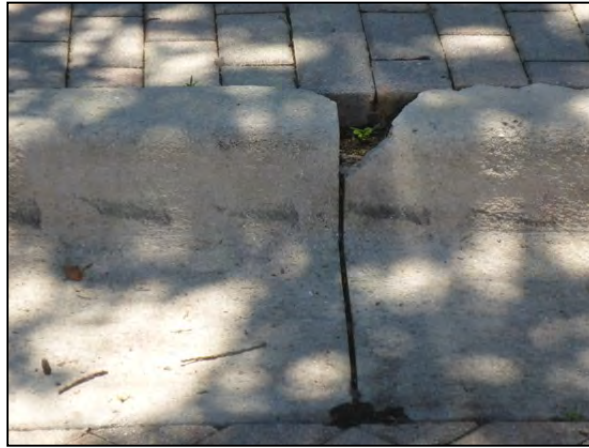
Picture 27 (P27)

Moderate fracture in type "F" curb with missing concrete.

Replace portions of curb.

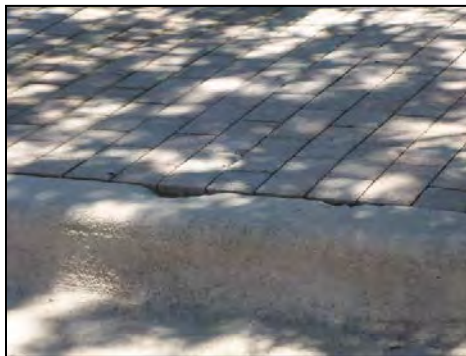
Picture 28 (P28)

Moderate fractures in the top of type "F" curb with missing concrete.

Replace portions of curb.

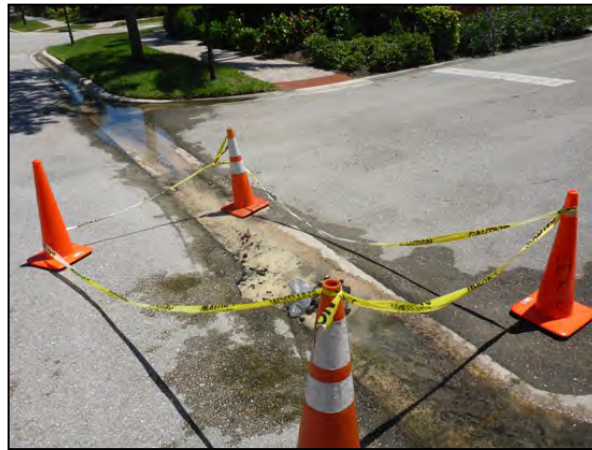
Picture 29 (P29)

City of Fort Myers watermain Leak.

City of Fort Myers to fix water leak and repair pavement.

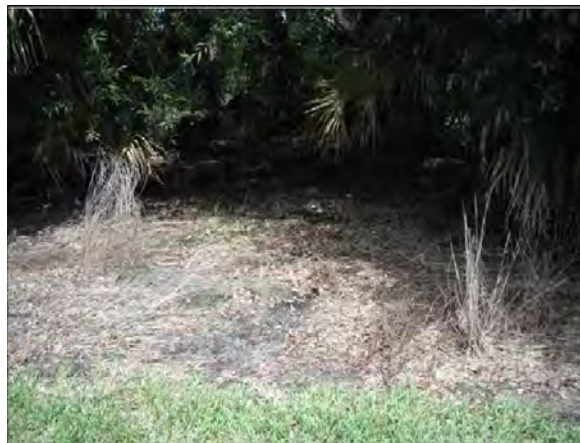
Picture 30 (P30)

Berm is eroded and and potentially breached.

Restore berm and sod.

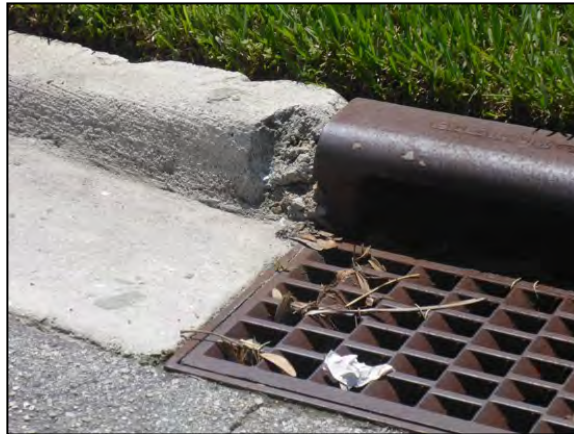
Picture 31 (P31)

Moderate fracture in type "F" curb with missing concrete adjacent to inlet.

Replace portion of curb.

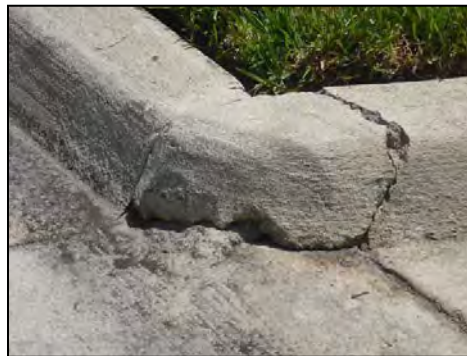
Picture 32 (P32)

Moderate fracture in type "F" curb with missing concrete.

Replace portion of curb.

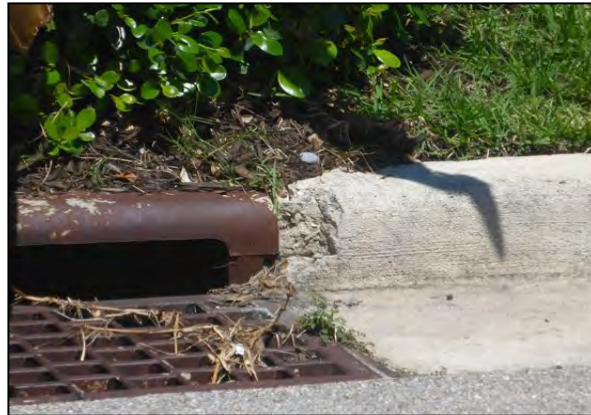
Picture 33 (P33)

Moderate fracture in type "F" curb with missing concrete adjacent to inlet.

Replace portion of curb.

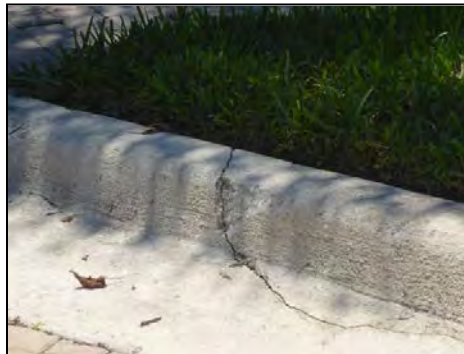
Picture 34 (P34)

Moderate fracture in type "F" curb with missing concrete.

Replace portion of curb.

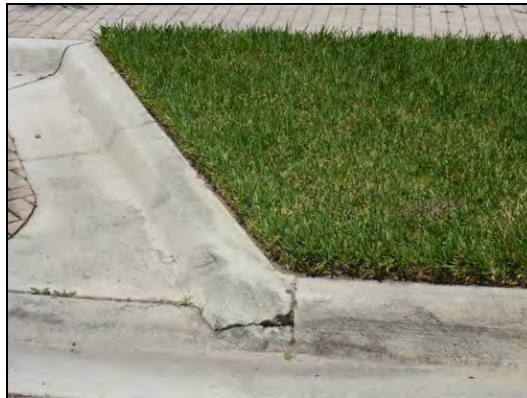
Picture 36 (P36)

Moderate fracture in type "F" curb with missing concrete and tire markings.

Replace portion of curb.

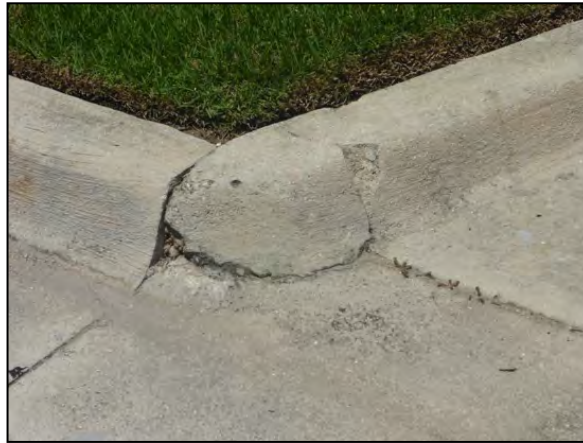
Picture 37 (P37)

Moderate fractures in type "F" curb with missing concrete.

Replace portion of curb.

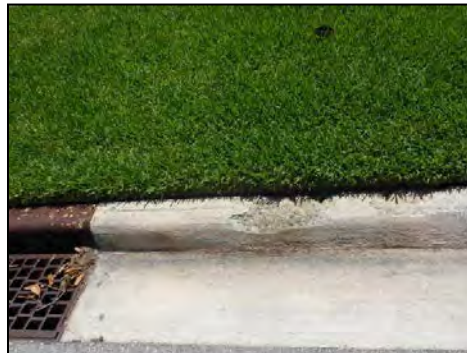
Picture 38 (P38)

Type "F" curb with missing concrete pieces.

Repair/replace portion of curb.

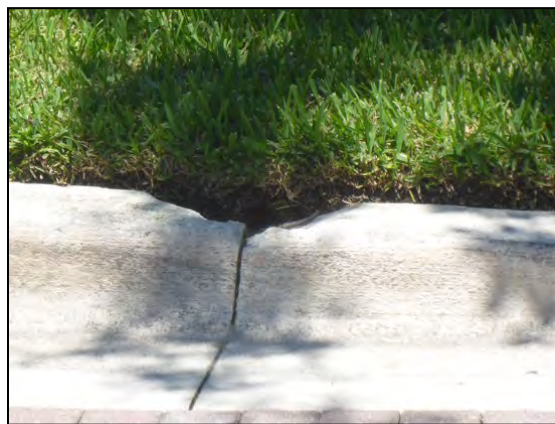
Picture 40 (P40)

Moderate fracture in the top of type "F" curb with missing concrete.

Repair/replace portion of curb.

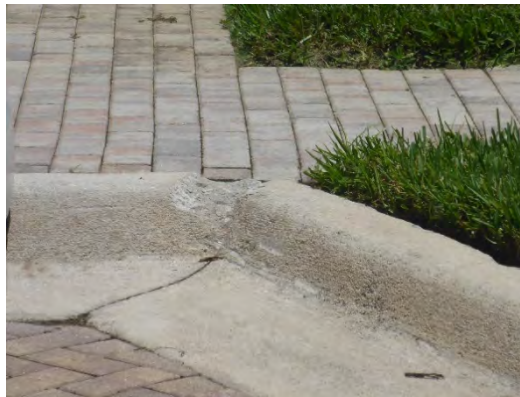
Picture 41 (P41)

Moderate fracture in the top of type "F" curb with missing concrete.

Replace portion of curb.

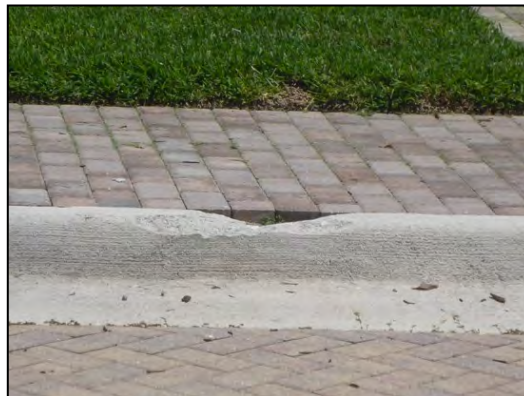
Picture 42 (P42)

Moderate fracture in the top of type "F" curb with substantial missing concrete.

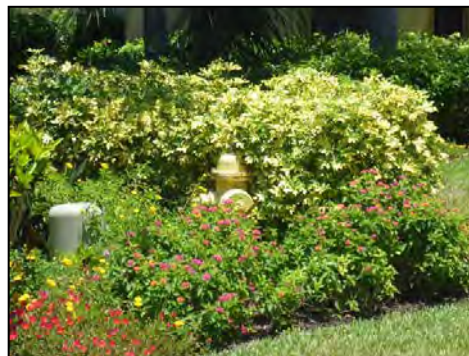
Picture 44 (P44)

Fire hydrant is obstructed by landscaping.

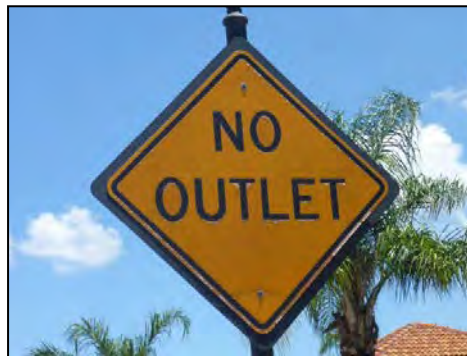
Picture 46 (P46)

Traffic sign is faded and peeling.

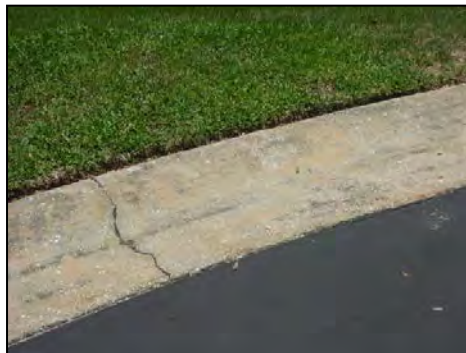
Picture 52 (P52)

Moderate fracture in valley gutter curb.

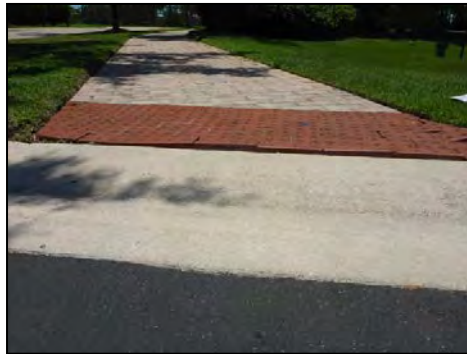
Picture 54 (P54)

Settling of ADA detectable warning device creating a potential tripping hazard.

Repair/re-install detectable warning device flush with curb.

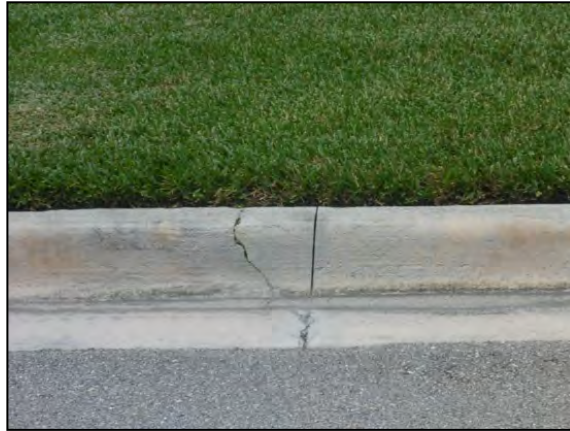
Picture 55 (P55)

Moderate fracture in type "F" curb.

Replace portion of curb.

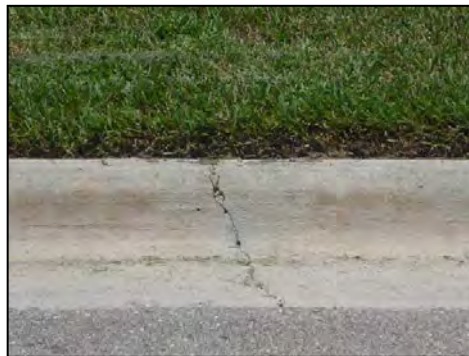
Picture 56 (P56)

Moderate fracture in type "F" curb.

Replace portion of curb.

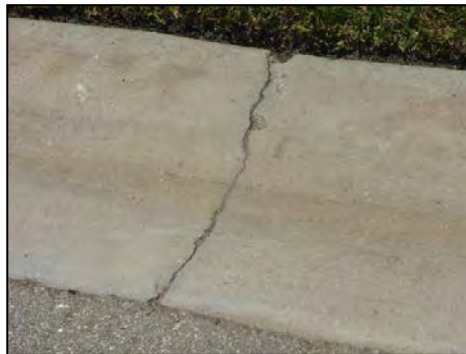
Picture 58 (P58)

Moderate fracture in valley gutter curb.

Replace portion of curb.

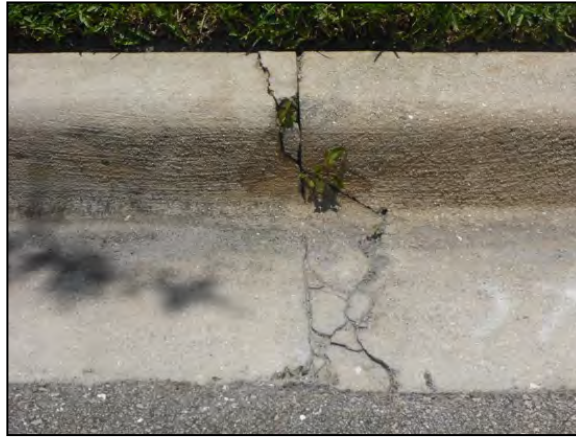
Picture 61 (P61)

Moderate fractures in type "F" curb with missing concrete.

Replace portion of curb.

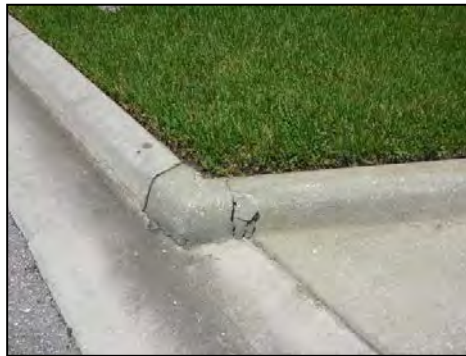
Picture 62 (P62)

Moderate fractures in type "F" curb with loose concrete pieces.

Replace/repair portion of curb.

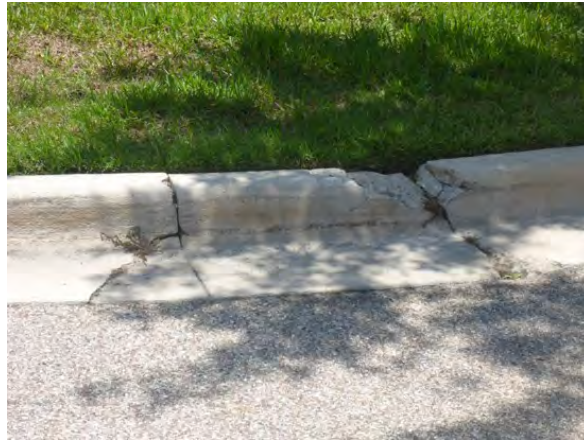
Picture 63 (P63)

Type "F" curb with multiple fractures and substantial missing concrete.

Replace portion of curb.

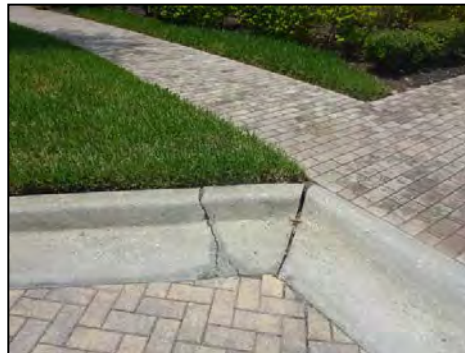
Picture 64 (P64)

Moderate fracture in type "F" curb.

Replace portion of curb.

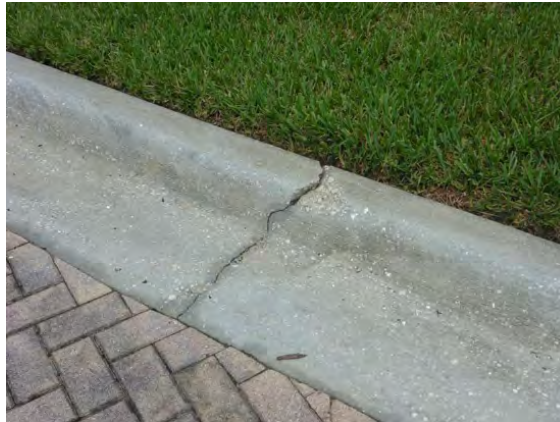
Picture 65 (P65)

Description:
Moderate fracture in type "F" curb.

Recommended Action:
Replace portion of curb.

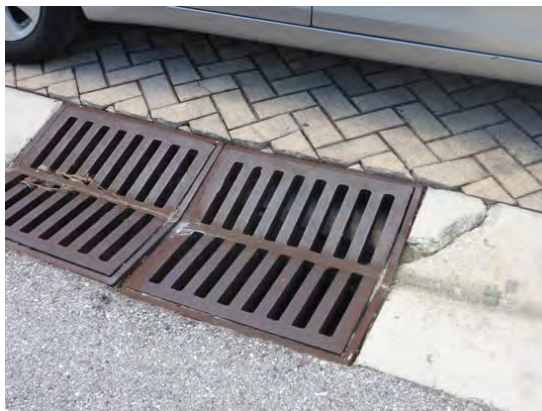
Picture 66 (P66)

Description:
Substantial fracture in valley gutter curb adjacent to inlet with loose concrete chunk.

Recommended Action:
Replace portion of curb.

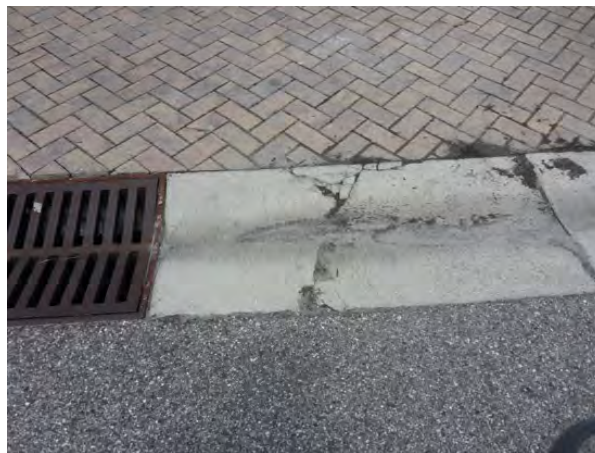
Picture 70 (P70)

Moderate fractures in valley gutter curb adjacent to inlet with missing concrete pieces.

Replace portion of curb.

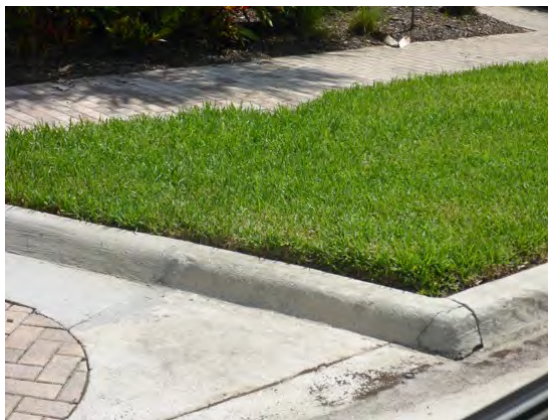
Picture 72 (P72)

Moderate fracture in type "F" curb with missing concrete.

Replace portion of curb.

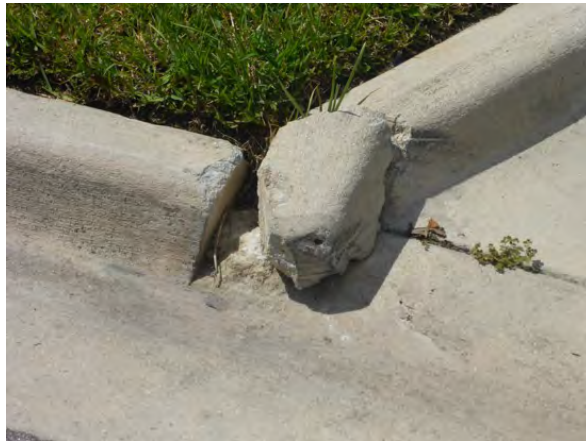
Picture 73 (P73)

Substantial fracture in type "F" curb with loose concrete chunk.

Replace portion of curb.

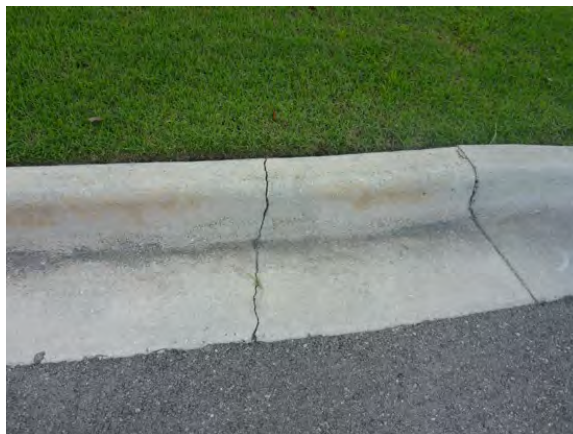
Picture 74 (P74)

Moderate fracture in type "F" curb.

Replace portion of curb.

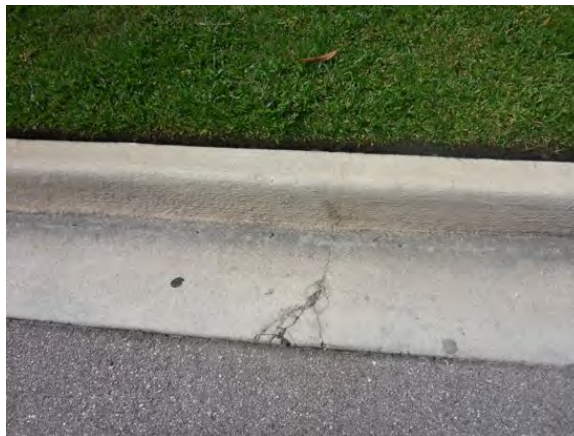
Picture 76 (P76)

Moderate fracture in type "F" curb.

Replace portion of curb.

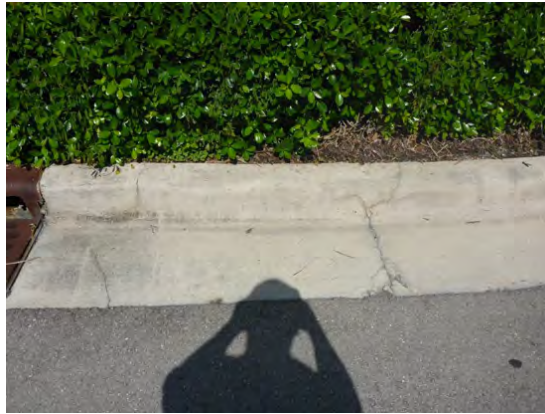
Picture 77 (P77)

Moderate fractures in type "F" curb adjacent to inlet.

Replace portion of curb.

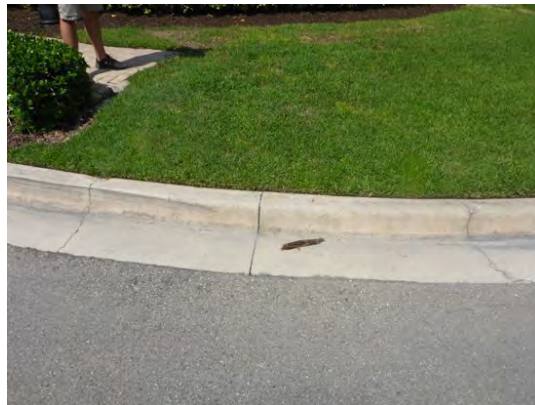
Picture 78 (P78)

Moderate fractures in type "F" curb.

Replace portion of curb.

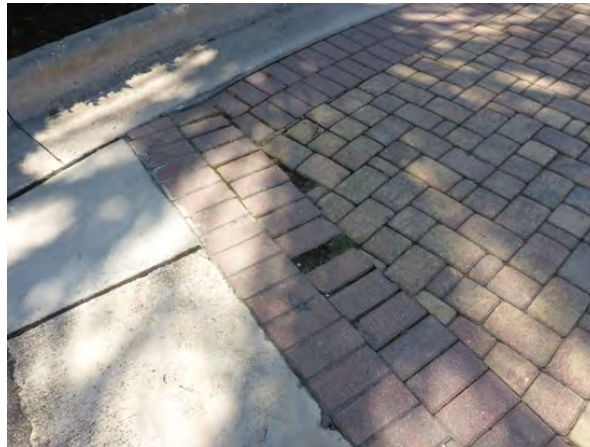
Picture 79 (P79)

Small dip in paver bricks and missing paver bricks.

Replace and reset paver bricks.

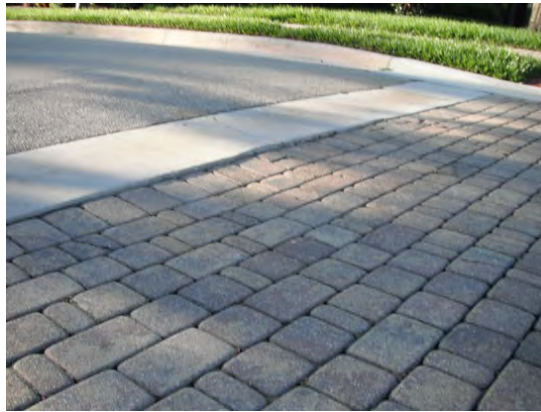
Picture 83 (P83)

Dip in crosswalk paver bricks adjacent to ribbon curb.

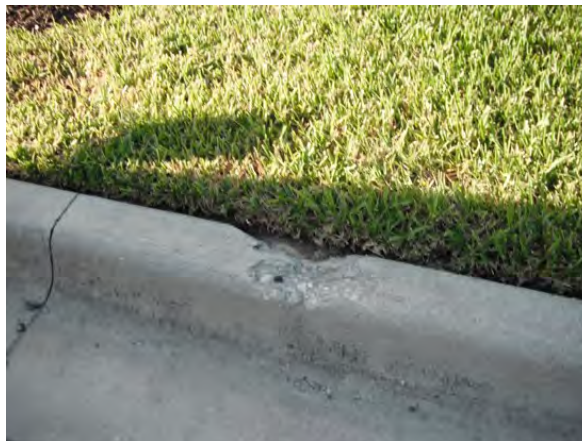
Picture 86 (P86)

Type "F" curb broken with missing concrete pieces.

Repair/replace portion of curb.

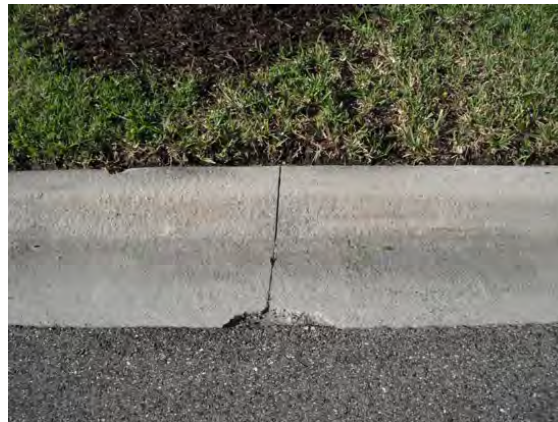
Picture 88 (P88)

Type "F" curb broken with missing concrete piece.

Repair/replace portion of curb.

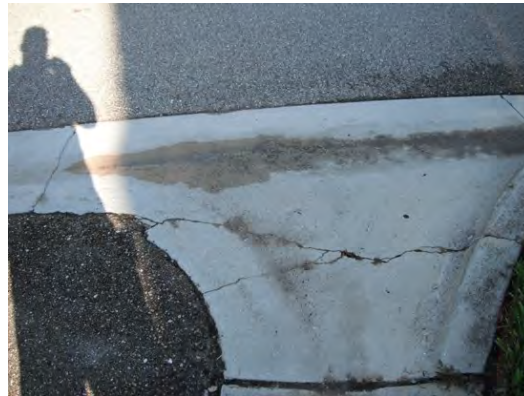
Picture 89 (P89)

Moderate fractures in curb transition from type "F" curb to valley gutter curb.

Replace portion of curb.

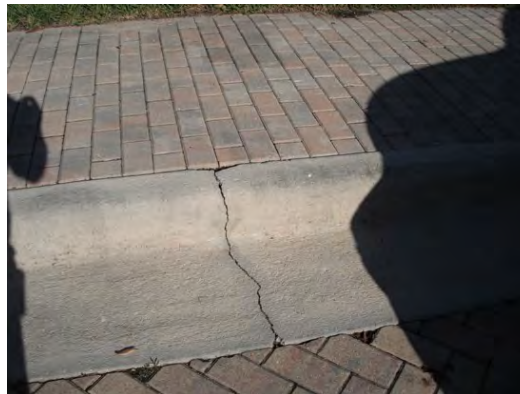
Picture 90 (P90)

Moderate fracture in type "F" curb with missing paver brick triangles.

Replace portion of curb and paver bricks.

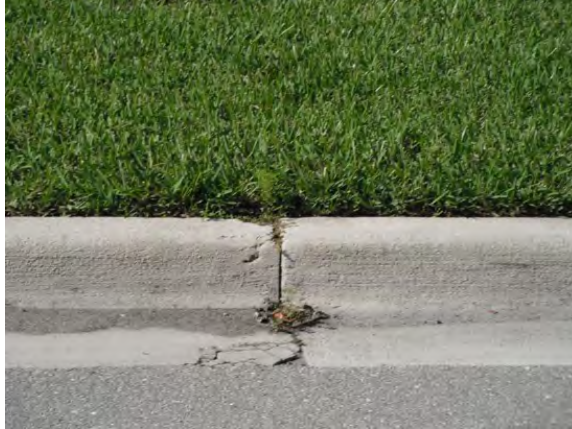
Picture 95 (P95)

Moderate fractures in type "F" curb with missing concrete.

Replace portion of curb.

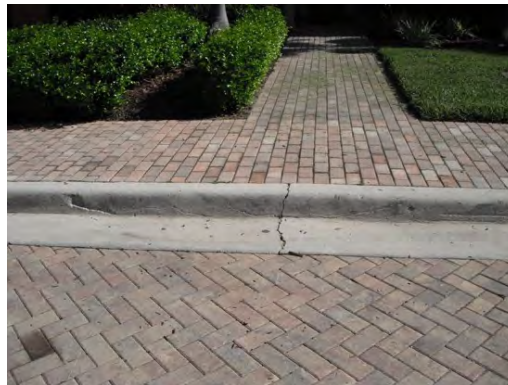
Picture 96 (P96)

Moderate fracture in type "F" curb with missing concrete.

Replace portion of curb.

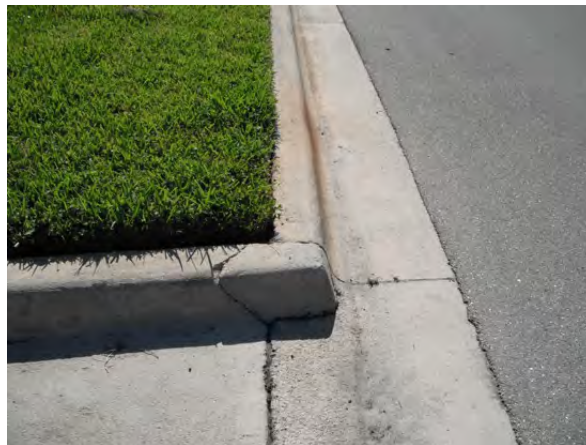
Picture 98 (P98)

Moderate fractures in type "F" curb with missing concrete.

Replace portion of curb.

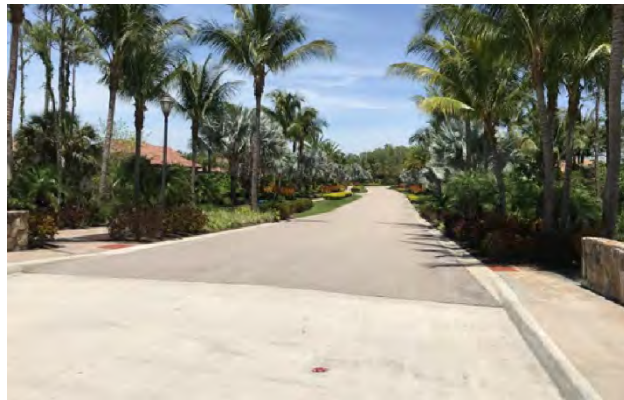
Picture 100 (P100)

Crosswalk signage missing and striping faded.

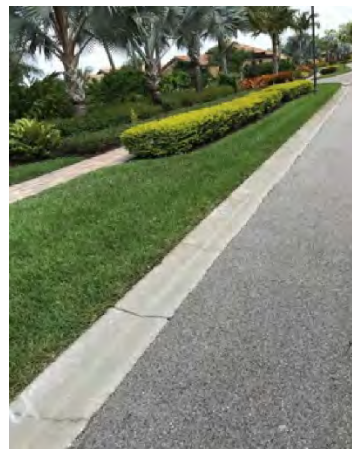
Picture 102 (P102)

Multiple moderate fractures in valley gutter curb.

Replace portion of curb.

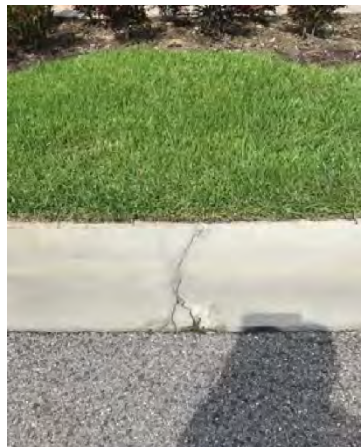
Picture 104 (P104)

Moderate fracture in valley gutter curb with missing concrete.

Replace portion of curb.

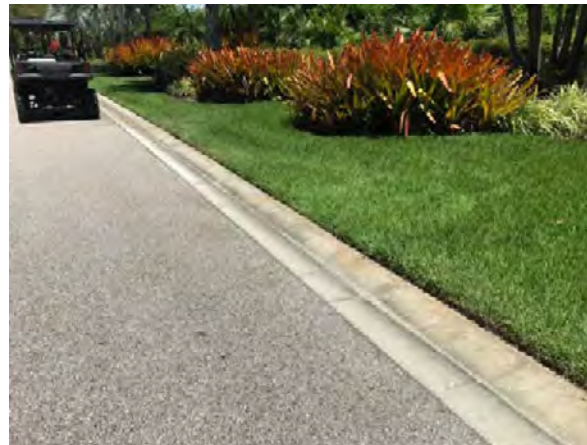
Picture 106 (P106)

Multiple moderate fractures in valley gutter curb.

Replace portion of curb.

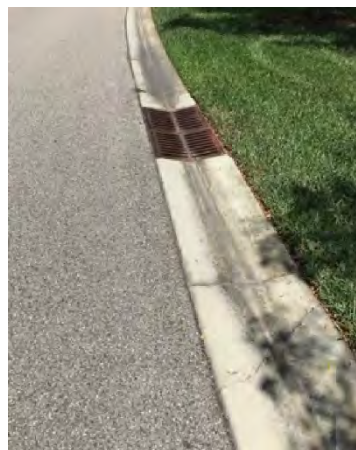
Picture 108 (P108)

Multiple moderate fractures in valley gutter curb adjacent to inlet.

Replace portion of curb.

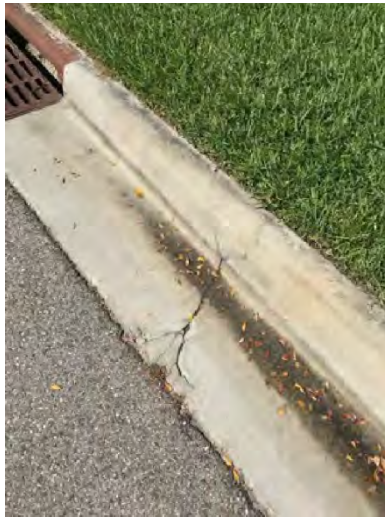
Picture 109 (P109)

Moderate fracture in type "F" curb with missing concrete.

Replace portion of curb.

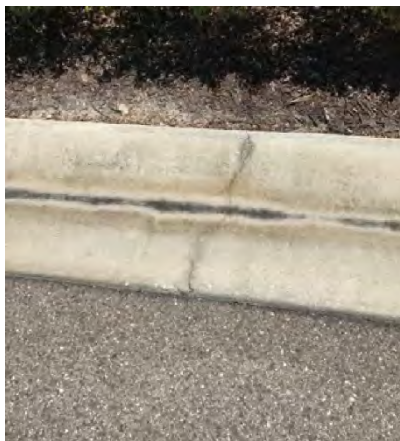
Picture 110 (P110)

Moderate fracture in valley gutter curb.

Replace portion of curb.

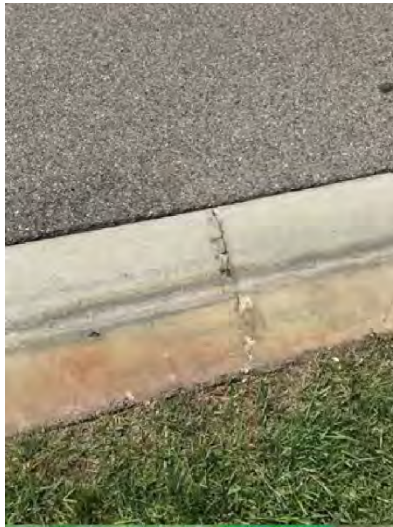
Picture 111 (P111)

Moderate fracture in valley gutter with loose concrete pieces.

Replace portion of curb.

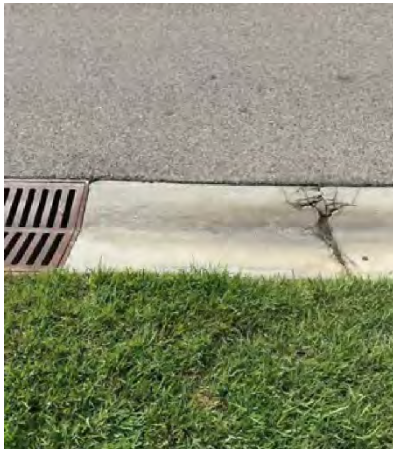
Picture 112 (P112)

Moderate fractures in valley gutter curb with missing concrete adjacent to inlet.

Replace portion of curb.

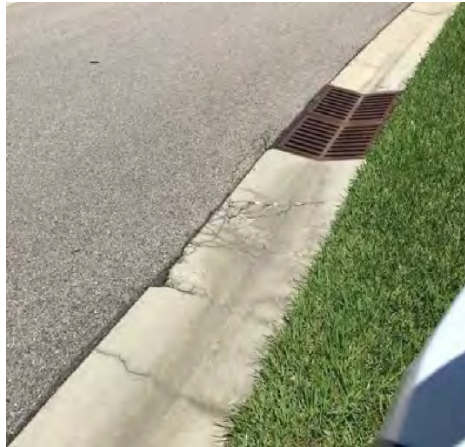
Picture 113 (P113)

Multiple moderate fractures in valley gutter curb with loose and missing concrete pieces adjacent to inlet.

Replace portion of curb.

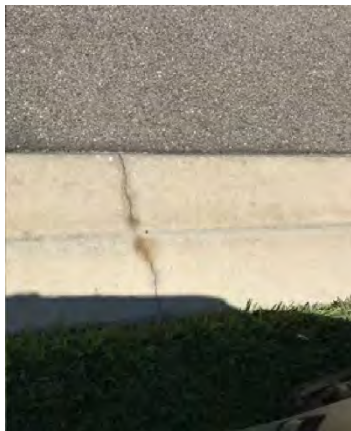
Picture 114 (P114)

Moderate fracture in valley gutter curb.

Replace portion of curb.

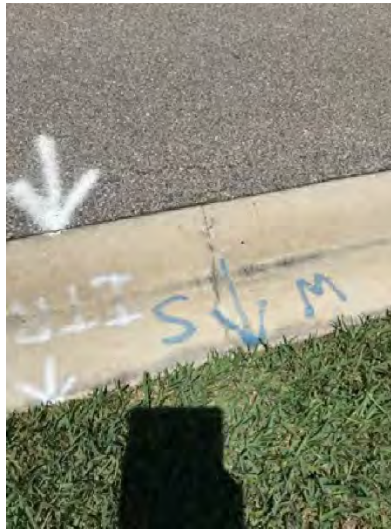
Picture 115 (P115)

Moderate fracture in valley gutter curb.

Replace portion of curb.

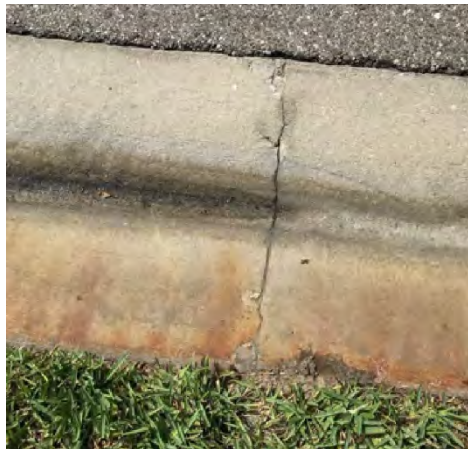
Picture 116 (P116)

Moderate fracture in valley gutter curb with missing concrete.

Replace portion of curb.

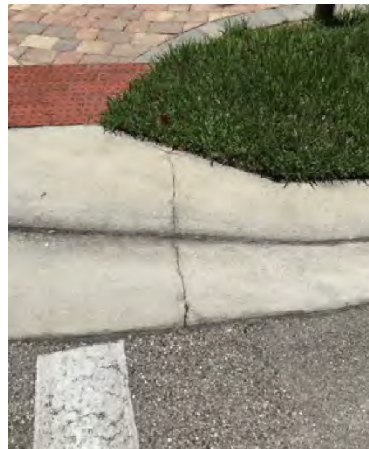
Picture 118 (P118)

Moderate fracture in curb transition with missing concrete.

Replace portion of curb.

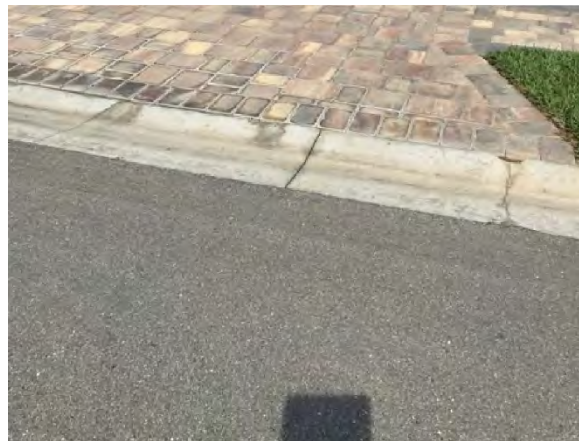
Picture 122 (P122)

Moderate fractures in valley gutter curb with missing concrete.

Replace portion of curb.

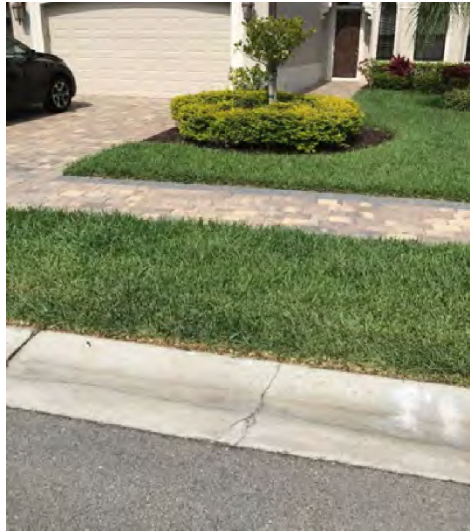
Picture 123 (P123)

Moderate fracture in valley gutter curb with loose concrete pieces.

Replace portion of curb.

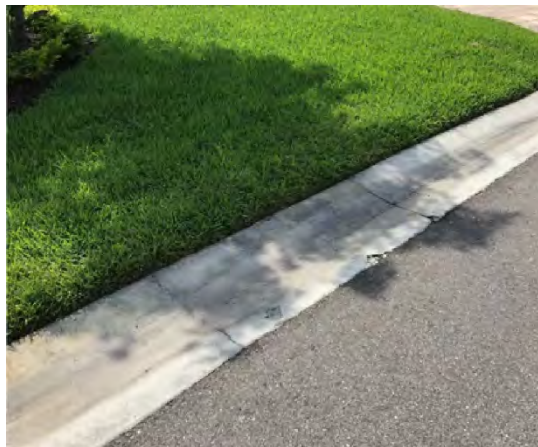
Picture 124 (P124)

Moderate fractures in valley gutter curb with missing concrete.

Replace portion of curb.

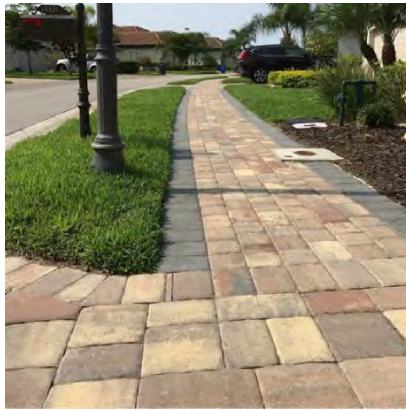
Picture 125 (P125)

Paver bricks settling around concrete valve pad creating tripping hazard.

Notify City of Fort Myers Utilities department.

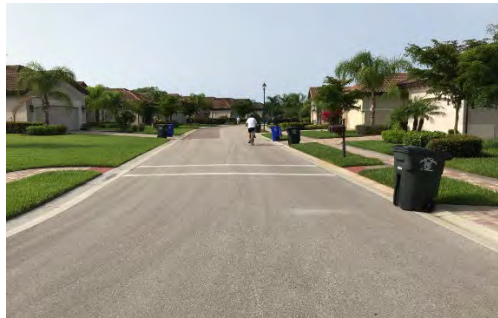
Picture 126 (P126)

Crosswalk signage missing.

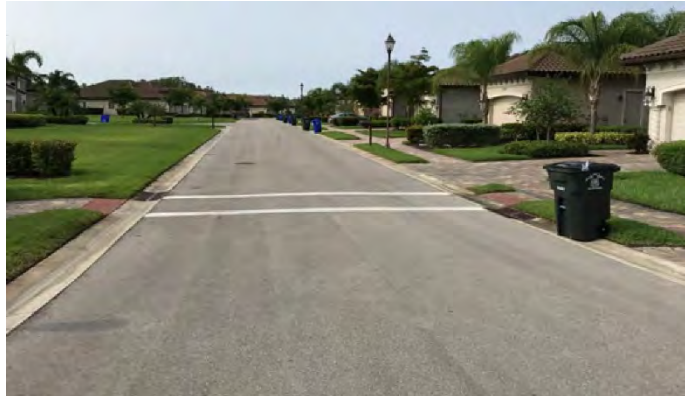
Picture 128 (P128)

Description:
Crosswalk signage missing.

Recommended Action:
Consider installing midblock crossing signage throughout.

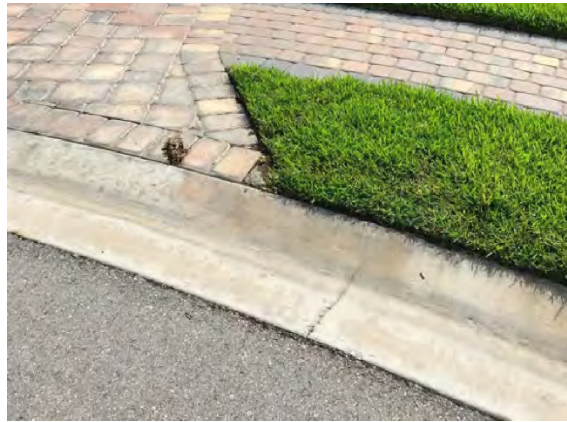
Picture 129 (P129)

Description:
Moderate fracture in valley gutter curb.

Recommended Action:
Replace portion of curb.

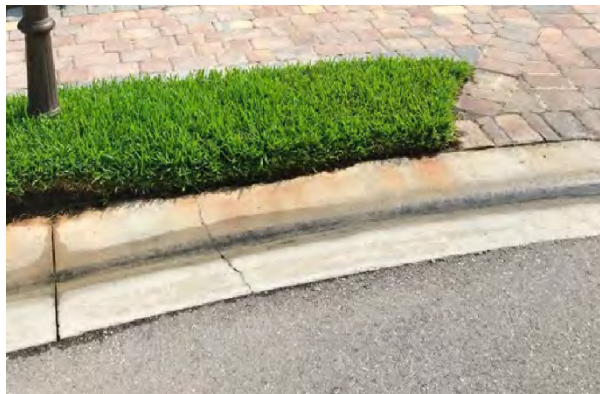
Picture 130 (P130)

Description:
Moderate fracture valley gutter curb with missing concrete.

Recommended Action:
Replace portion of curb.

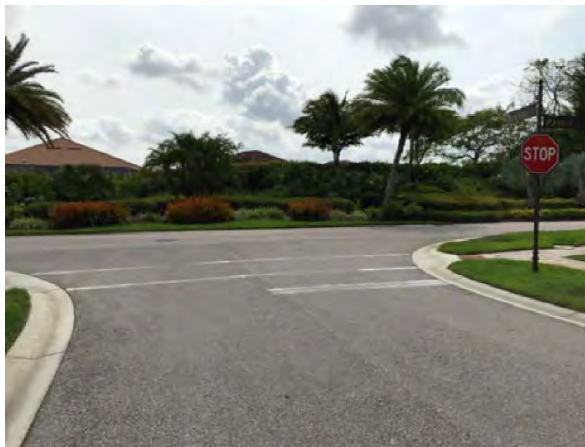
Picture 132 (P132)

Stop bar and crosswalk striping faded.

Repaint stop bar and crosswalk striping.

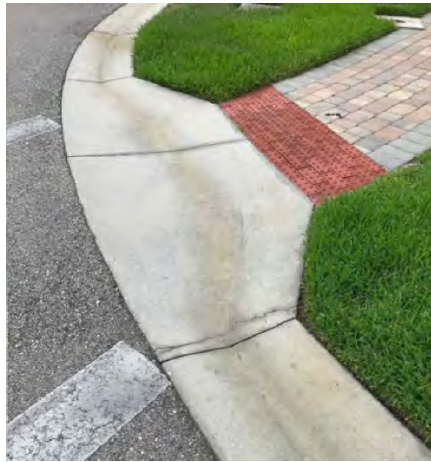
Picture 133 (P133)

Moderate fracture in curb transition.

Replace portion of curb.

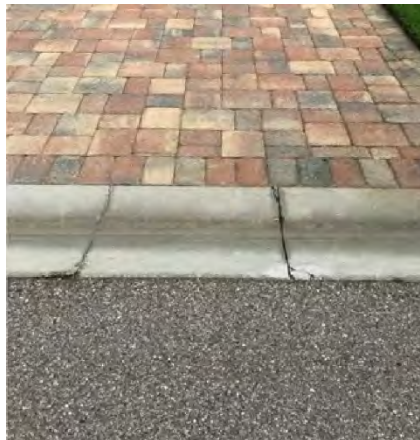
Picture 134 (P134)

Moderate fractures in valley gutter curb with missing concrete.

Replace portion of curb.

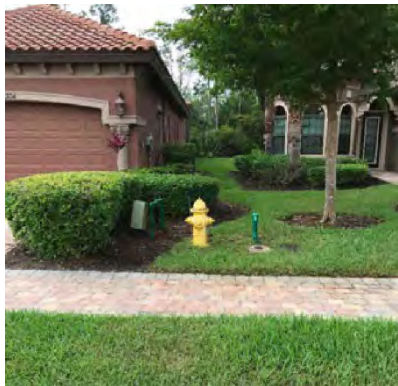
Picture 135 (P135)

Fire hydrant valve buried.

Notify City of Fort Myers Utilities department.

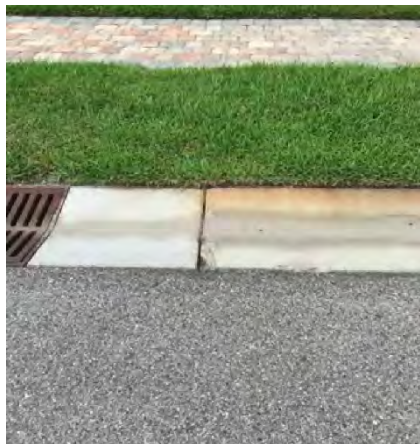
Picture 136 (P136)

Moderate fractures in valley gutter curb adjacent to inlet with missing concrete.

Replace portion of curb.

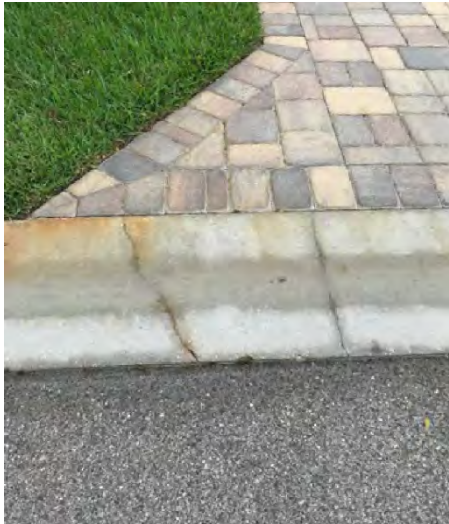
Picture 137 (P137)

Moderate fracture in valley gutter curb.

Replace portion of curb.

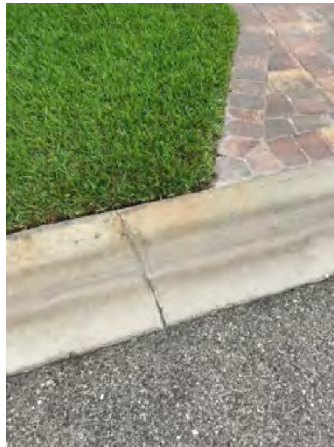
Picture 138 (P138)

Moderate fracture in valley gutter curb.

Replace portion of curb.

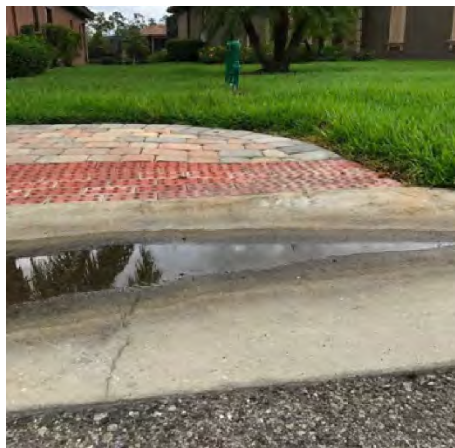
Picture 140 (P140)

Paver bricks and detectable warning device settling unevenly.

Reset paver bricks and detectable warning device.

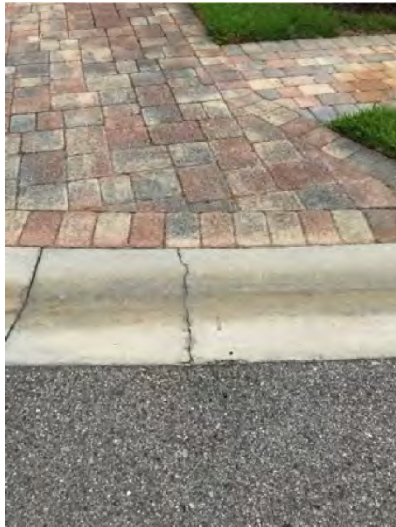
Picture 141 (P141)

Moderate fracture in valley gutter curb.

Replace portion of curb.

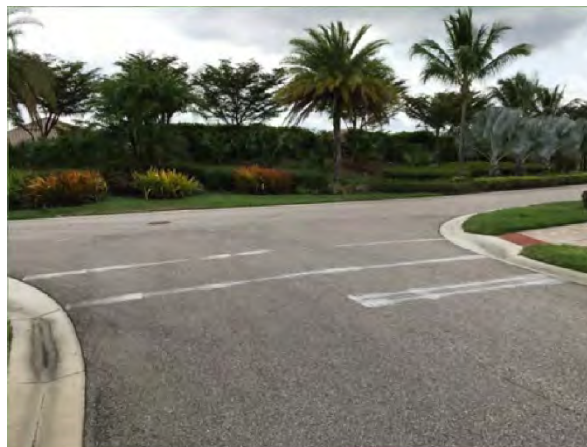
Picture 144 (P144)

Stop bar and crosswalk striping faded.

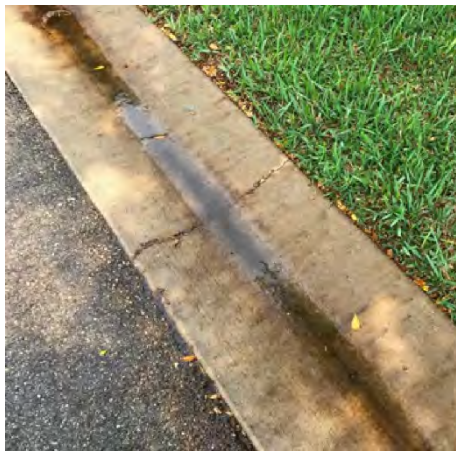
Picture 146 (P146)

Moderate fracture in valley gutter curb.

Replace portion of curb.

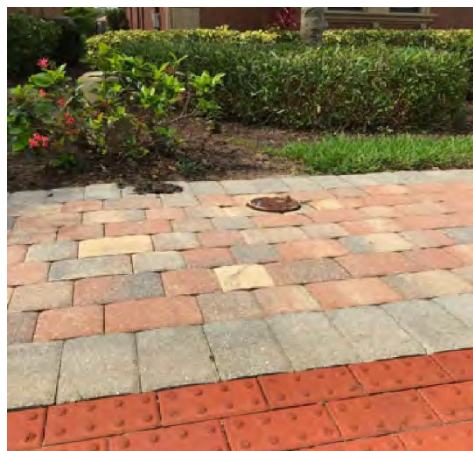
Picture 148 (P148)

Paver bricks settling at water valve creating trip hazard.

Notify City of Fort Myers Utilities department.

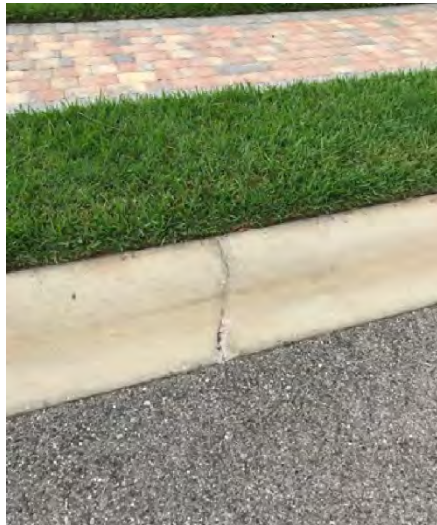
Picture 149 (P149)

Moderate fracture in valley gutter curb with missing concrete

Replace portion of curb.
