Paseo Community Development District

**Board of Supervisors' Meeting
July 22, 2020**

Barraco and Associates, serving as the District Engineer for the Paseo Community Development District (District), was requested to perform an overall site observation of specific District assets. This observation included review of the perimeter berm, concrete curb, roadway asphalt, brick paver and concrete sidewalks, roadway striping and signage, visible irrigation appurtenances, visible City of Fort Myers' water and sewer appurtenances for deficiencies and/ or required maintenance.

MAINTENANCE AND DEFICIENCIES NOTED

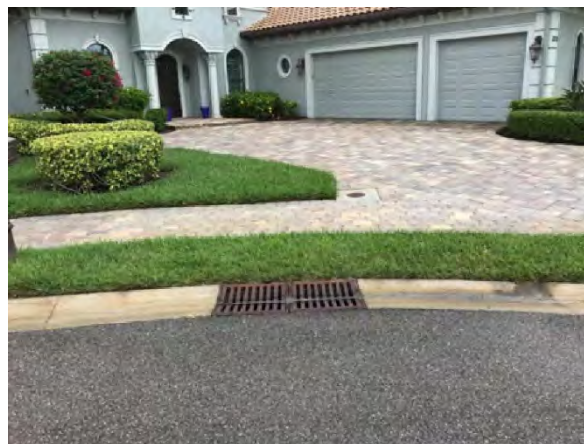
Picture 154 (P154)

Moderate fractures in valley gutter curb adjacent to inlet.

Replace portion of curb.

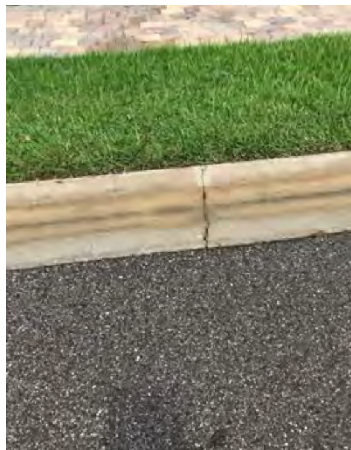
Picture 156 (P156)

Moderate fracture in valley gutter curb with loose concrete pieces.

Replace portion of curb.

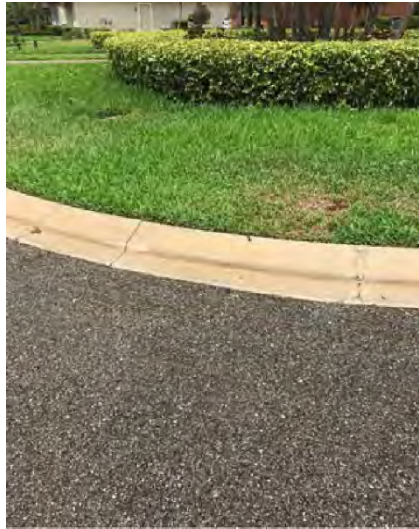
Picture 157 (P157)

Moderate fractures in type "A" curb with loose concrete pieces.

Replace portion of curb.

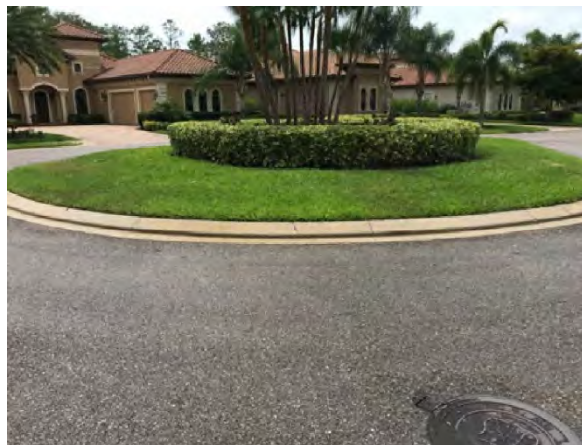
Picture 158 (P158)

Multiple moderate fractures in type "A" curb with missing concrete.

Replace portion of curb.

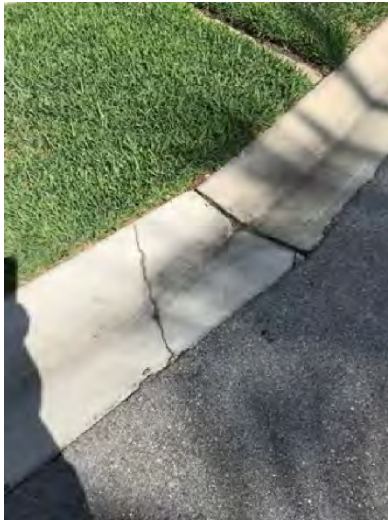
Picture 159 (P159)

Moderate fracture in valley gutter curb.

Replace portion of curb.

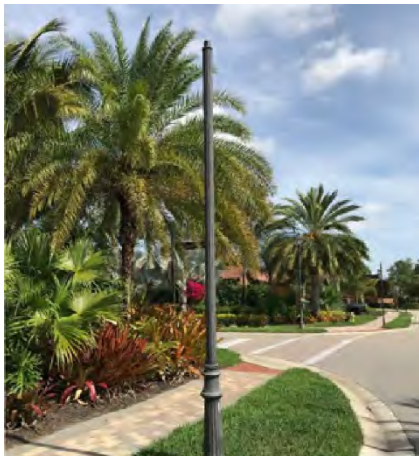
Picture 160 (P160)

Missing streetlight head.

Install missing streetlight head.

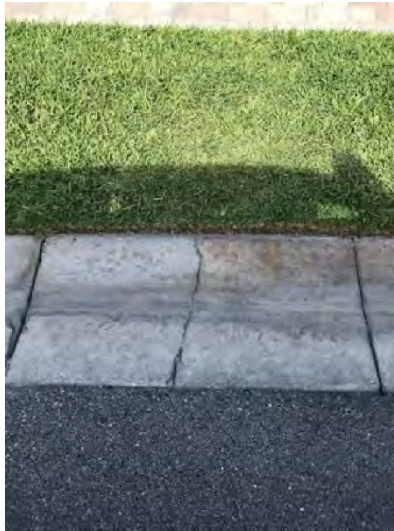
Picture 161 (P161)

Moderate fracture in valley gutter curb.

Replace portion of curb.

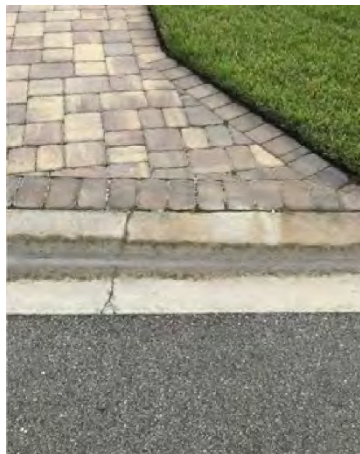
Picture 162 (P162)

Moderate fracture in valley gutter curb with loose concrete pieces.

Replace portion of curb.

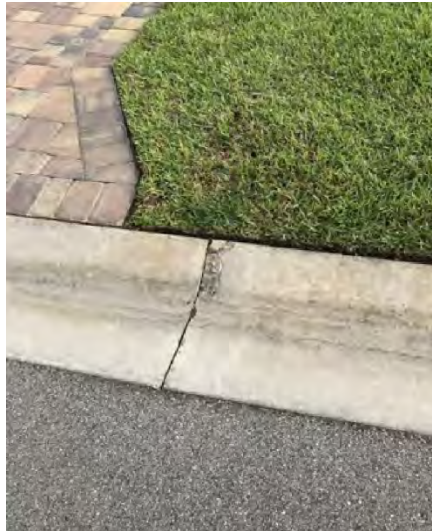
Picture 165 (P165)

Moderate fracture in valley gutter curb with missing and loose concrete pieces.

Replace portion of curb.

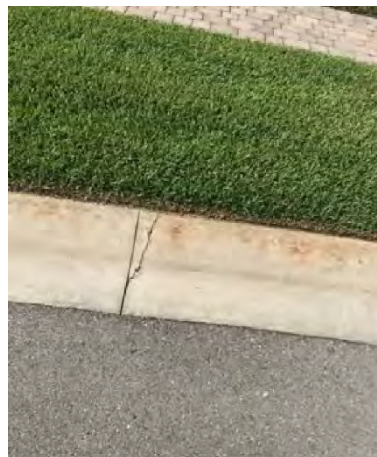
Picture 166 (P166)

Moderate fracture in valley gutter curb.

Replace portion of curb.

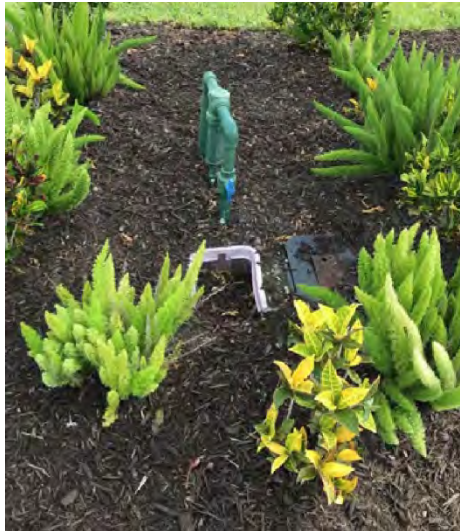
Picture 167 (P167)

Missing irrigation meter lid.

Replace lid.

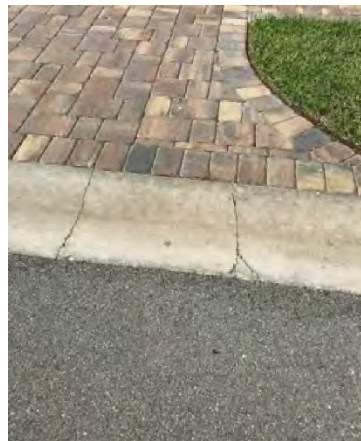
Picture 168 (P168)

Moderate fractures in valley gutter curb.

Replace portion of curb.

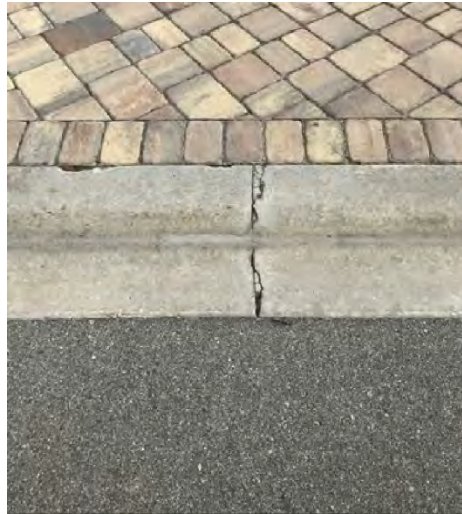
Picture 169 (P169)

Moderate fracture in valley gutter curb with loose concrete pieces.

Replace portion of curb.

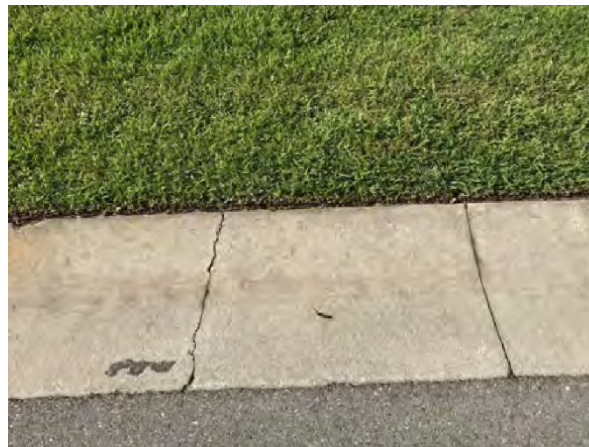
Picture 170 (P170)

Moderate fracture in valley gutter curb.

Replace portion of curb.

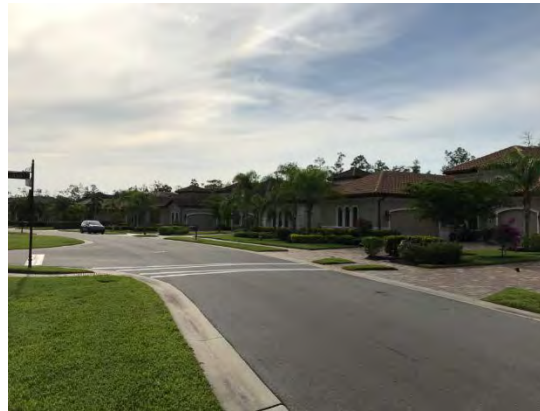
Picture 171 (P171)

Crosswalk signage missing and multiple crosswalk stripes.

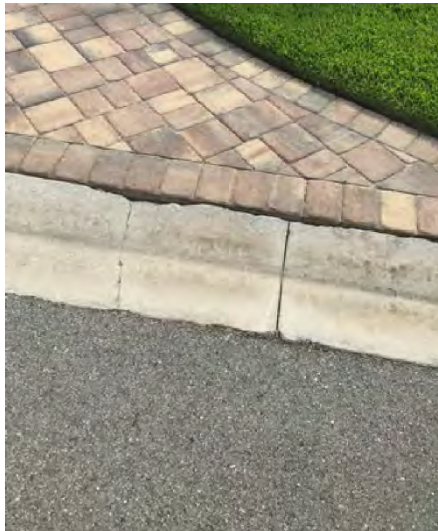
Picture 173 (P173)

Moderate fracture in valley gutter curb with missing concrete.

Replace portion of curb.

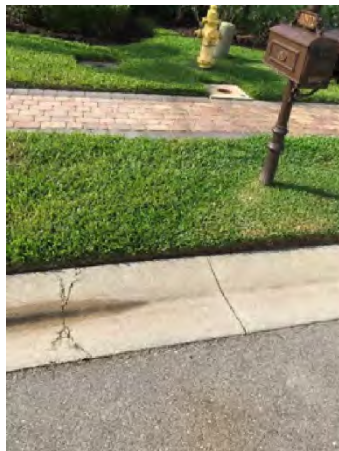
Picture 174 (P174)

Moderate fractures in valley gutter curb.

Replace portion of curb.

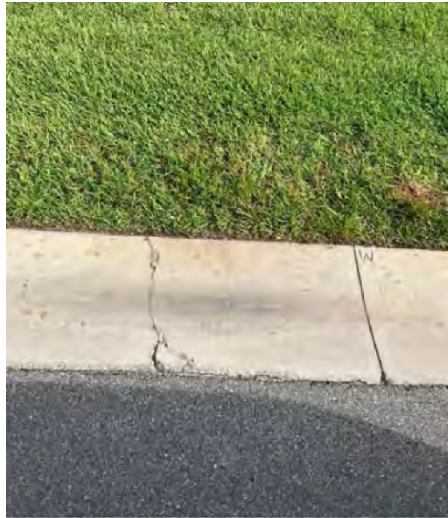
Picture 175 (P175)

Moderate fractures in valley gutter curb with loose concrete pieces.

Replace portion of curb.

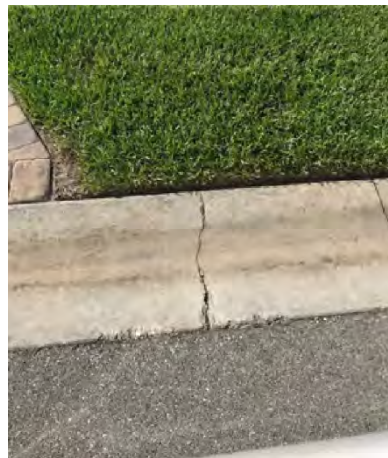
Picture 176 (P176)

Moderate fracture in valley gutter curb with missing concrete.

Replace portion of curb.

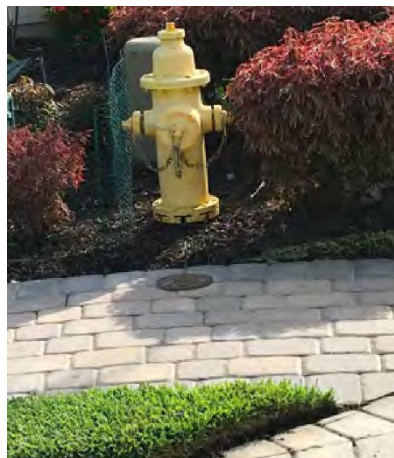
Picture 178 (P178)

Water valve ring and cover protruding from paver bricks creating tripping hazard.

Notify City of Fort Myers Utilities department.

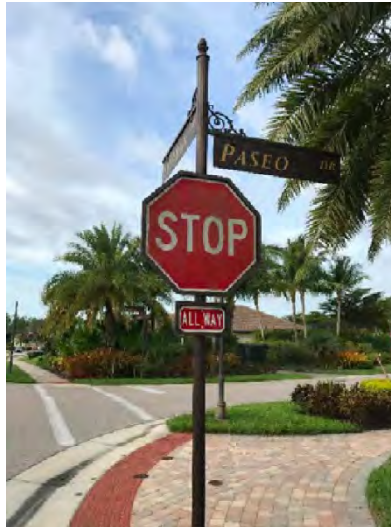
Picture 179 (P179)

Stop sign moldy and faded.

Replace stop sign.

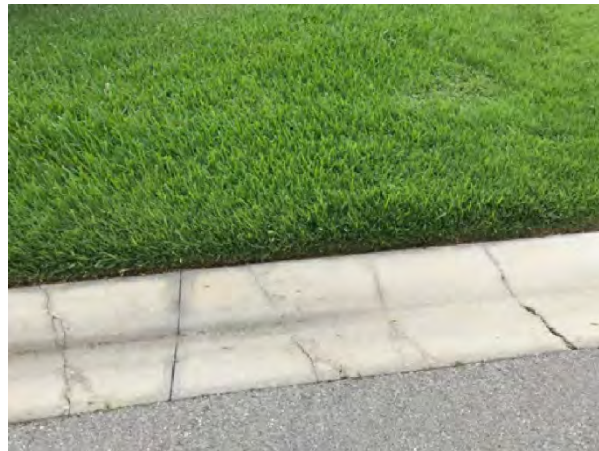
Picture 180 (P180)

Multiple moderate fractures in valley gutter curb with loose concrete pieces.

Replace portion of curb.

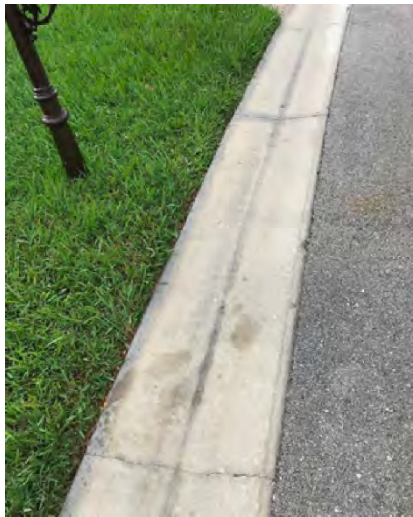
Picture 181 (P181)

Moderate fractures in valley gutter curb.

Replace portion of curb.

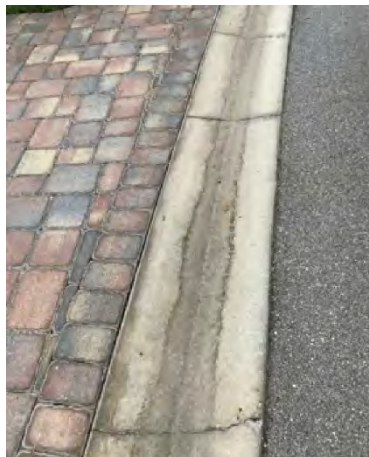
Picture 182 (P182)

Moderate fractures in valley gutter curb.

Replace portion of curb.

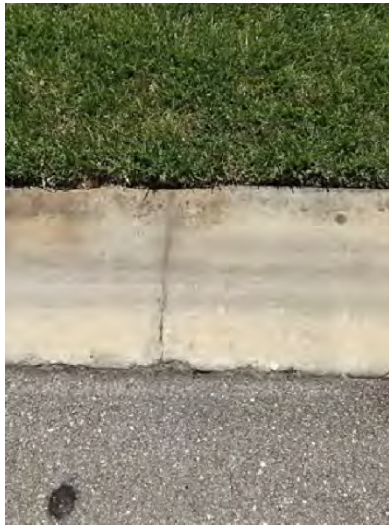
Picture 183 (P183)

Moderate fracture in valley gutter curb.

Replace portion of curb.

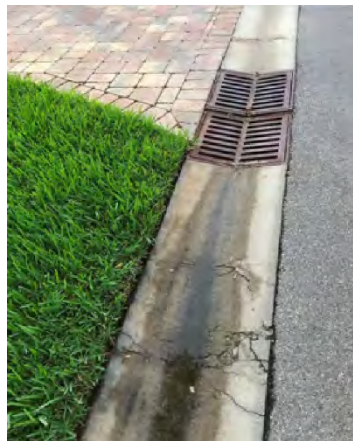
Picture 184 (P184)

Moderate fractures in valley gutter curb adjacent to inlet with loose concrete pieces.

Replace portion of curb.

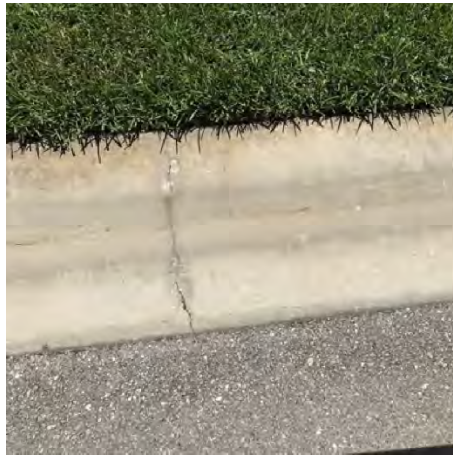
Picture 185 (P185)

Moderate fracture in valley gutter curb.

Replace portion of curb.

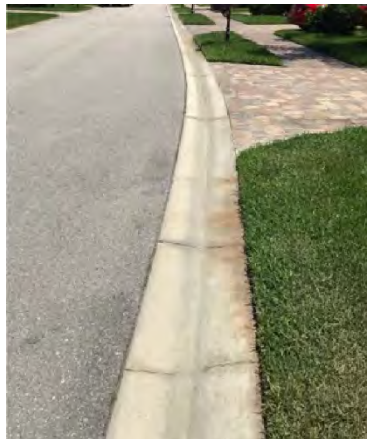
Picture 186 (P186)

Moderate fracture in valley gutter curb.

Replace portion of curb.

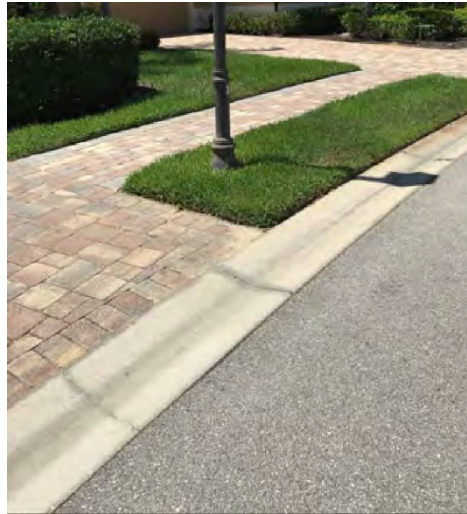
Picture 187 (P187)

Moderate fractures in valley gutter curb.

Replace portion of curb.

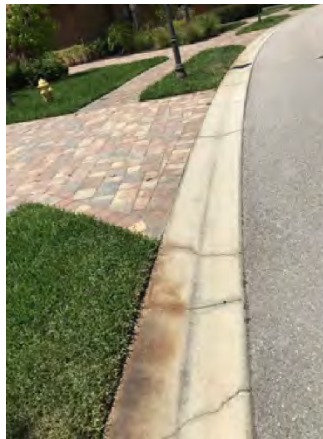
Picture 188 (P188)

Moderate fractures in valley gutter curb.

Replace portion of curb.

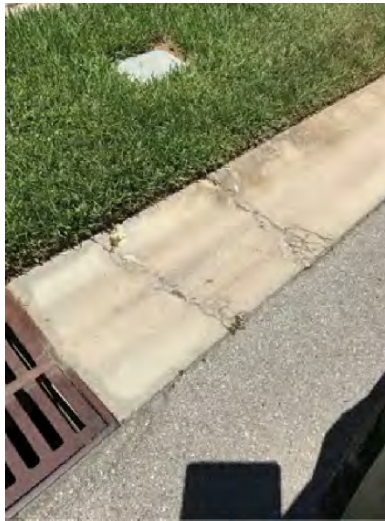
Picture 189 (P189)

Moderate fractures in valley gutter curb adjacent to inlet with loose concrete pieces.

Replace portion of curb.

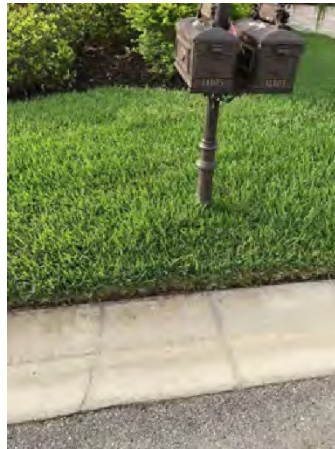
Picture 190 (P190)

Moderate fractures in valley gutter curb.

Replace portion of curb.

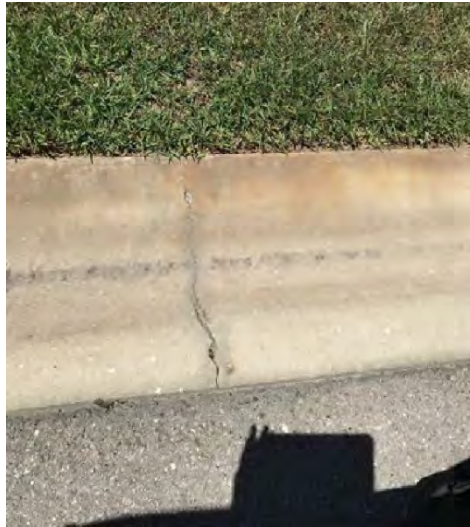
Picture 191 (P191)

Moderate fracture in valley gutter curb.

Replace portion of curb.

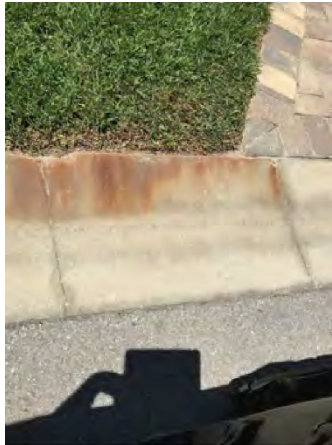
Picture 192 (P192)

Moderate fractures in valley gutter curb with missing concrete.

Replace portion of curb.

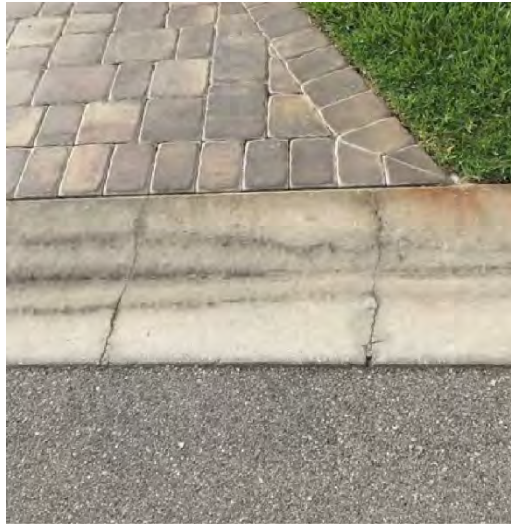
Picture 193 (P193)

Moderate fractures in valley gutter curb.

Replace portion of curb.

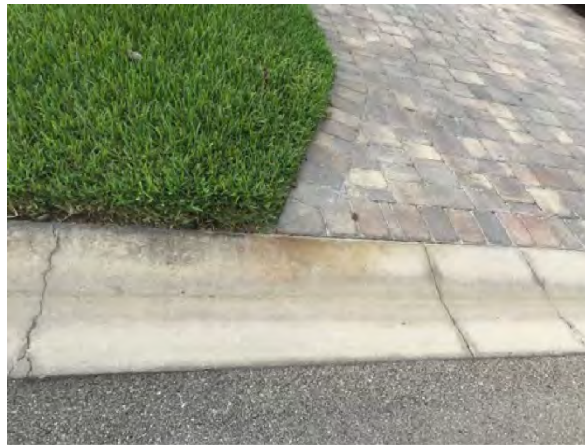
Picture 194 (P194)

Moderate fractures in valley gutter curb.

Replace portion of curb.

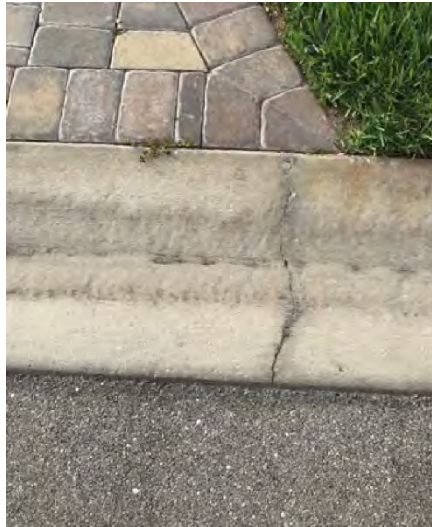
Picture 195 (P195)

Moderate fracture in valley gutter curb.

Replace portion of curb.

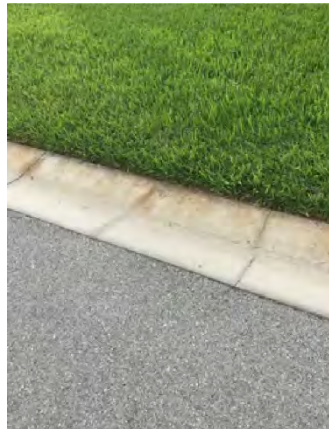
Picture 196 (P196)

Moderate fracture in valley gutter curb.

Replace portion of curb.

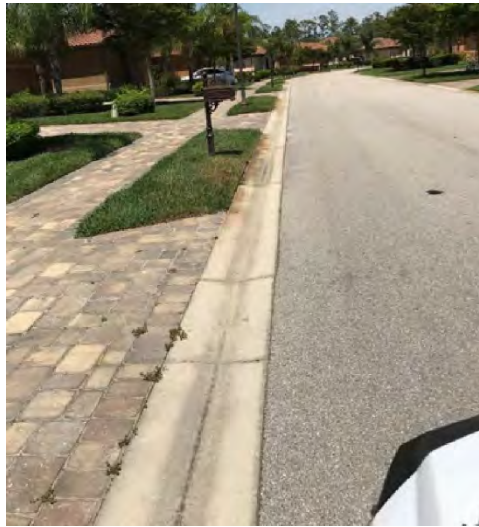
Picture 197 (P197)

Multiple moderate fractures in valley gutter curb and missing fire hydrant road pavement marker.

Replace portion of curb and install road pavement marker.

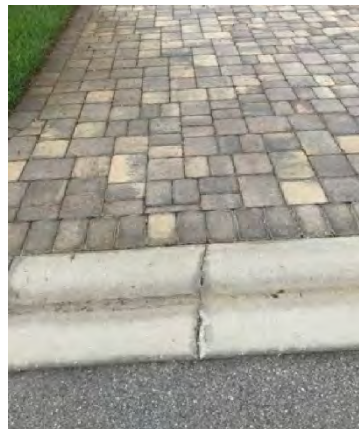
Picture 198 (P198)

Moderate fracture in valley gutter curb.

Replace portion of curb.

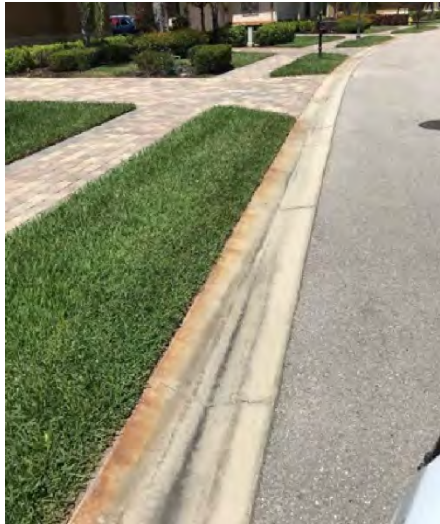
Picture 199 (P199)

Multiple moderate fractures in valley gutter curb.

Replace portion of curb.

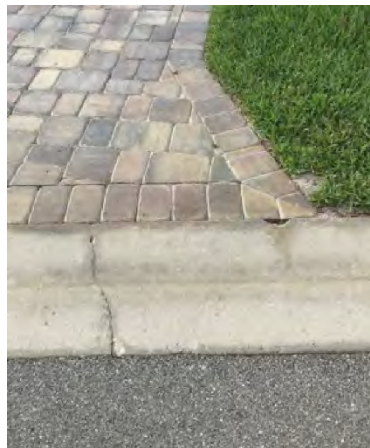
Picture 200 (P200)

Multiple moderate fractures in valley gutter curb with missing concrete.

Replace portion of curb.

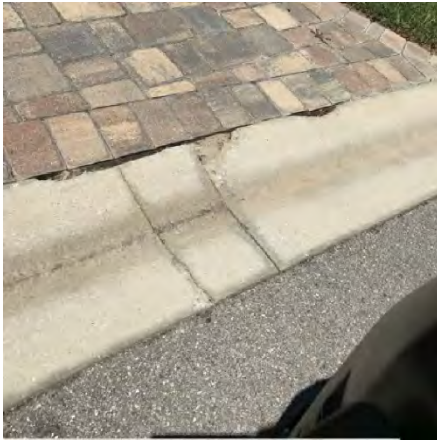
Picture 201 (P201)

Moderate fractures in valley gutter curb with missing concrete.

Replace portion of curb.

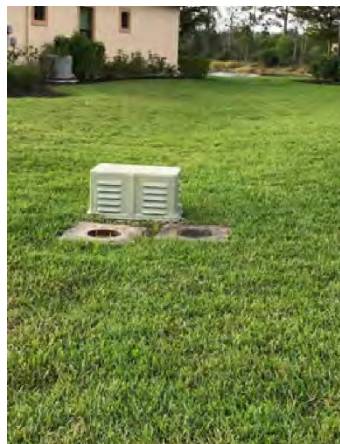
Picture 202 (P202)

Sanitary service valves missing lids.

Notify City of Fort Myers Utilities department.

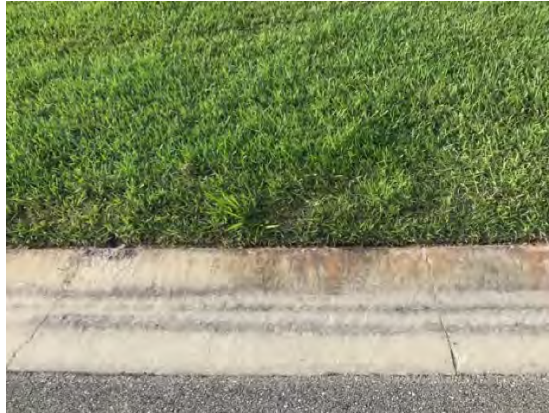
Picture 203 (P203)

Moderate fractures in valley gutter curb.

Replace portion of curb.

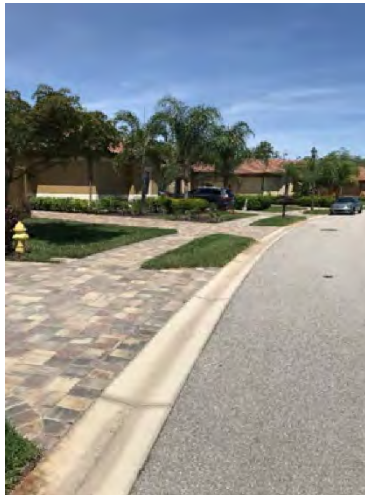
Picture 204 (P204)

Fire hydrant missing road pavement marker.

Install road pavement marker.

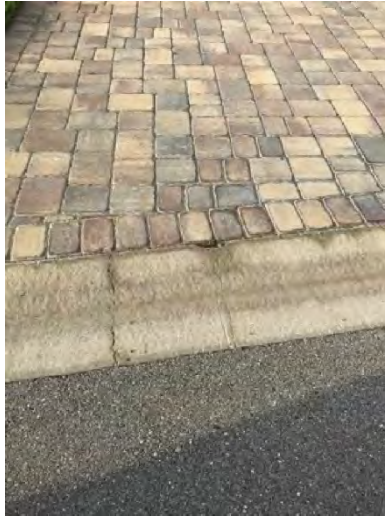
Picture 205 (P205)

Moderate fractures in valley gutter curb.

Replace portion of curb.

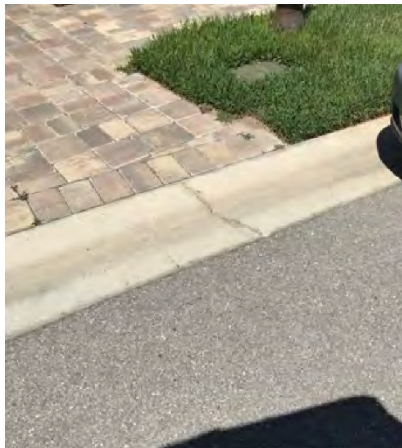
Picture 206 (P206)

Moderate fracture in valley gutter curb.

Replace portion of curb.

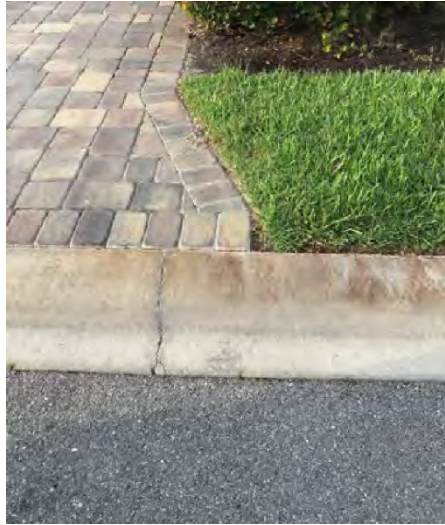
Picture 207 (P207)

Moderate fracture in valley gutter curb with loose concrete pieces.

Replace portion of curb.

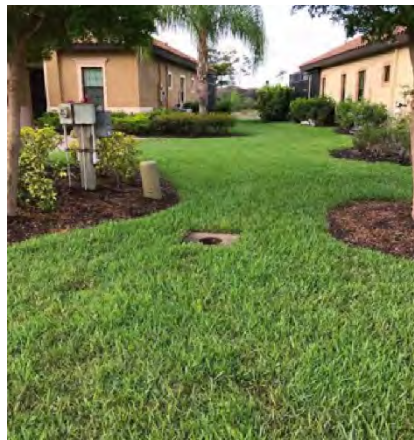
Picture 208 (P208)

Sanitary service valve missing lid.

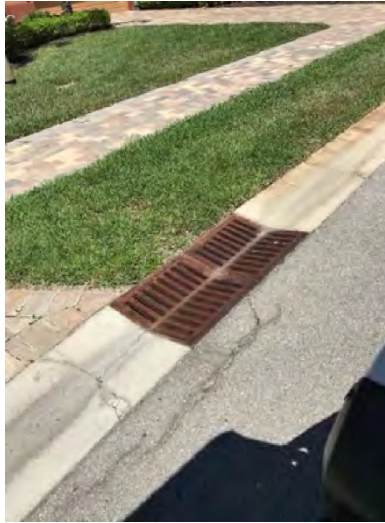
Picture 211 (P211)

Moderate fractures in both road pavement and valley gutter curb with loose concrete pieces.

Replace portion of curb.

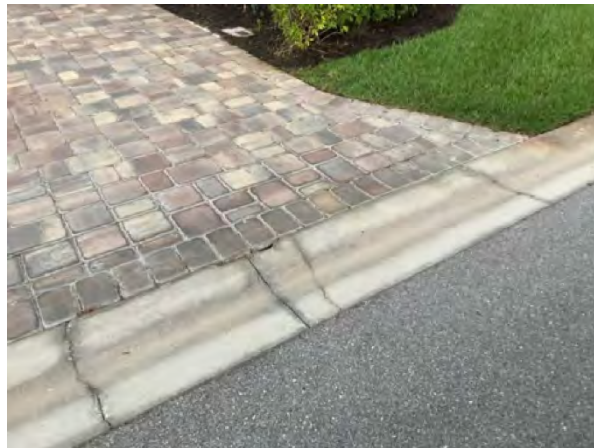
Picture 212 (P212)

Moderate fractures in valley gutter curb with missing concrete.

Replace portion of curb.

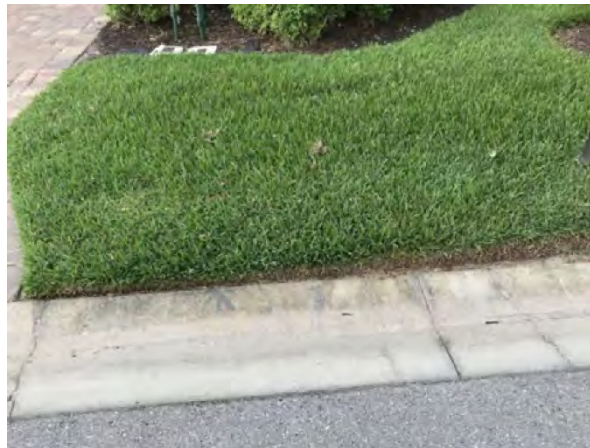
Picture 214 (P214)

Moderate fractures in valley gutter curb.

Replace portion of curb.

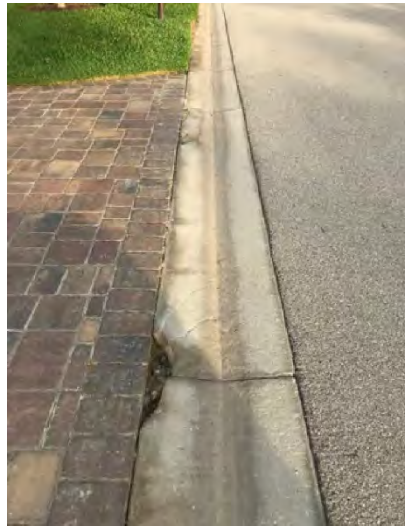
Picture 215 (P215)

Multiple moderate fractures in valley gutter curb with substantial missing concrete at the back of curb.

Replace portion of curb.

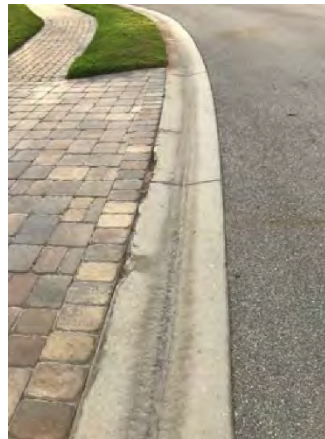
Picture 216 (P216)

Moderate fractures in valley gutter curb with substantial missing concrete at the back of curb.

Replace portion of curb.

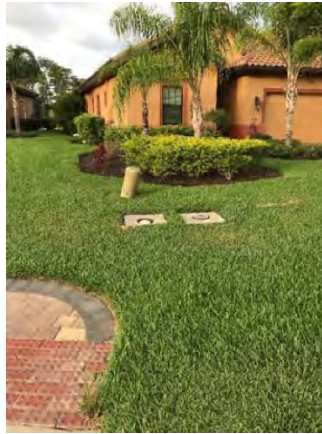
Picture 217 (P217)

Sanitary service missing lid.

Notify City of Fort Myers Utilities department.

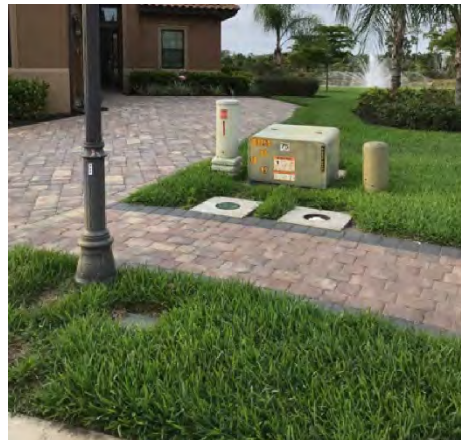
Picture 218 (P218)

Sanitary service missing lid.

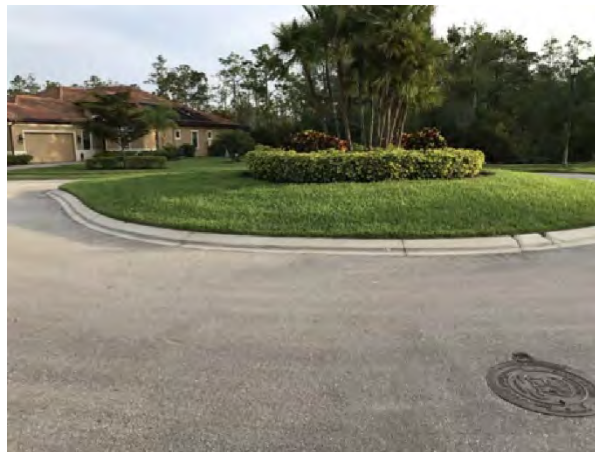
Picture 220 (P220)

Moderate fractures in type "A" curb with substantial missing concrete.

Replace portion of curb.

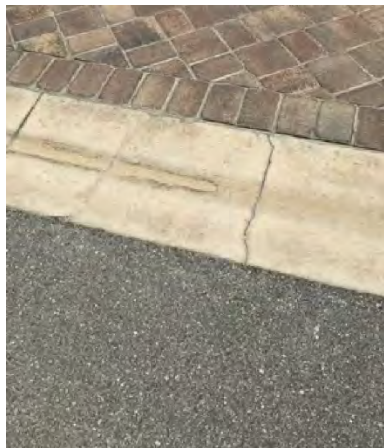
Picture 222 (P222)

Moderate fractures in valley gutter curb.

Replace portion of curb.

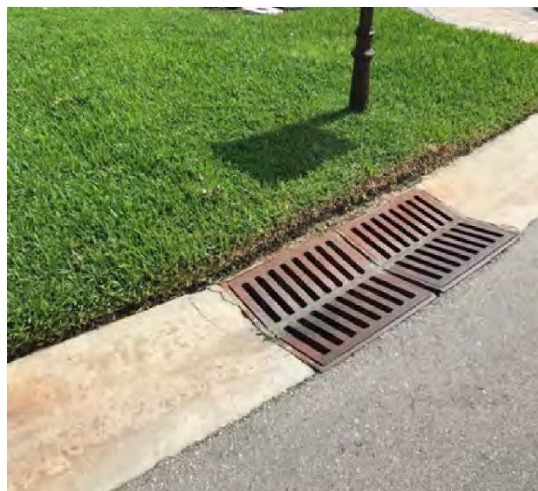
Picture 226 (P226)

Description:
Moderate fractures in valley gutter curb adjacent to inlet with loose concrete pieces.

Recommended Action:
Replace portion of curb.

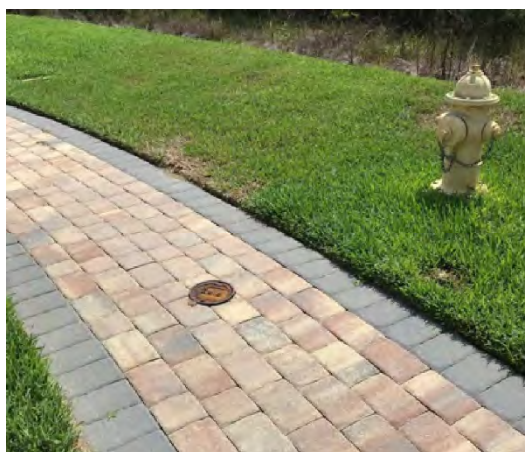
Picture 228 (P228)

Water valve ring and cover protruding from paver bricks creating tripping hazard.

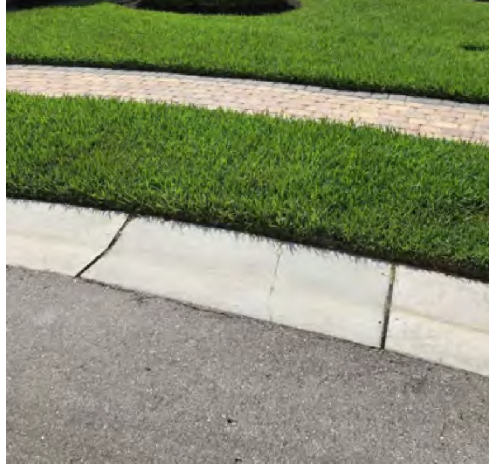
Picture 231 (P231)

Moderate fracture in valley gutter curb.

Replace portion of curb.

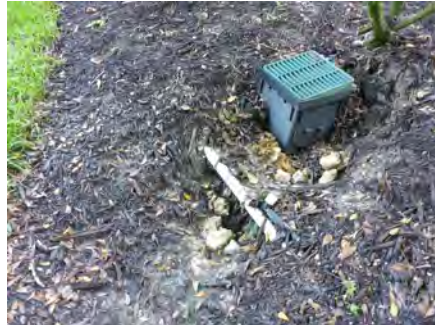
Picture 232 (P232)

Berm is eroded and potentially breached with exposed pipe.

Restore berm and mulch. Check irrigation for leak.

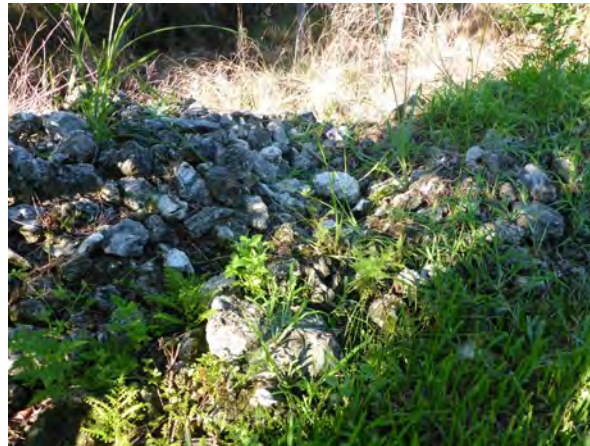
Picture 234 (P234)

Berm is eroded and potentially breached.

Restore berm with geotextile and rip-rap.

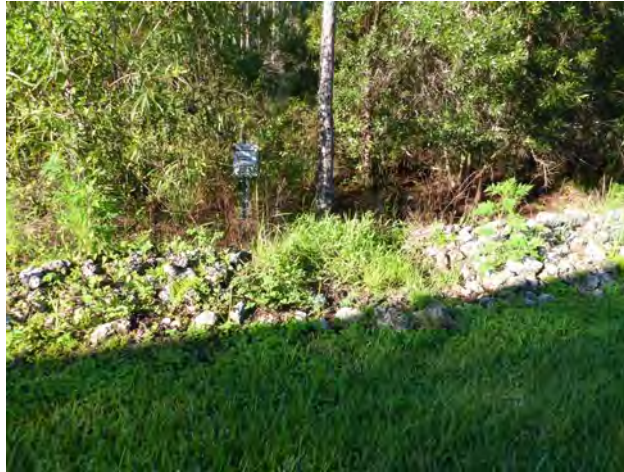
Picture 235 (P235)

Berm is eroded and potentially breached.

Restore berm with geotextile and rip-rap.

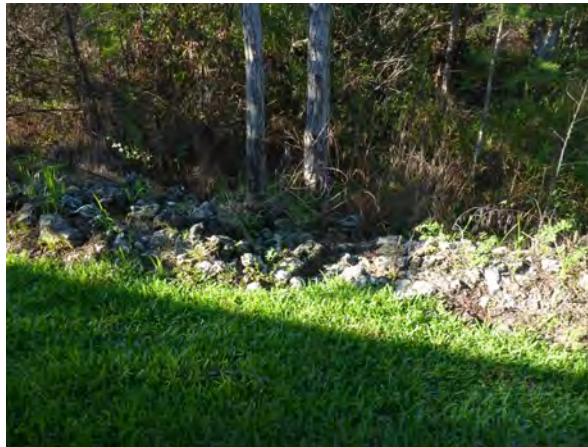
Picture 236 (P236)

Berm is eroded and potentially breached.

Restore berm with geotextile and rip-rap.

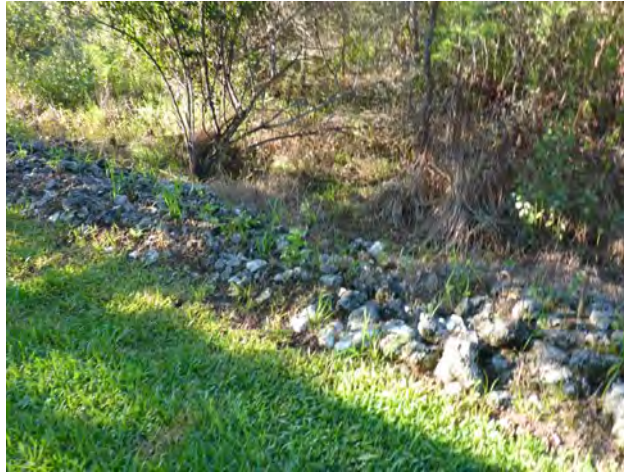
Picture 237 (P237)

Berm is eroded and potentially breached.

Restore berm with geotextile and rip-rap.

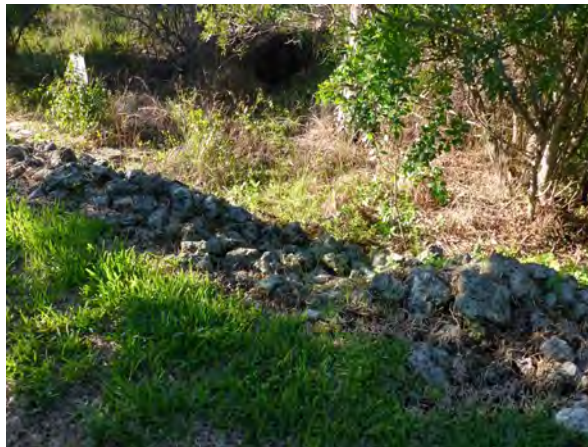
Picture 238 (P238)

Berm is eroded and potentially breached.

Restore berm with geotextile and rip-rap.

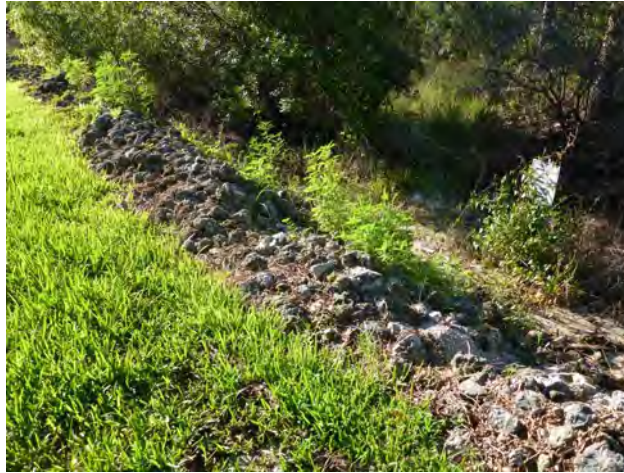
Picture 239 (P239)

Berm is eroded and potentially breached.

Restore berm with geotextile and rip-rap.

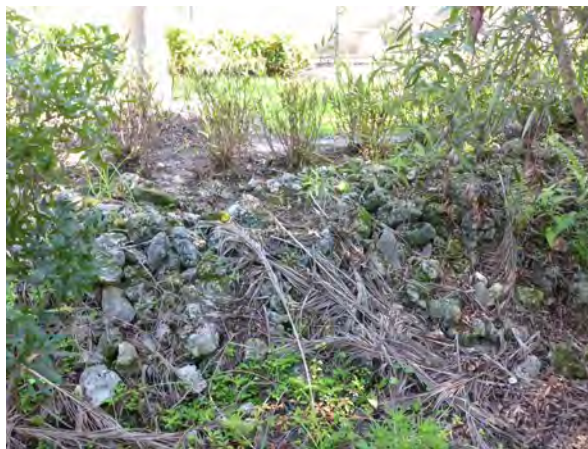
Picture 240 (P240)

Berm is eroded and potentially breached.

Restore berm with geotextile and rip-rap.

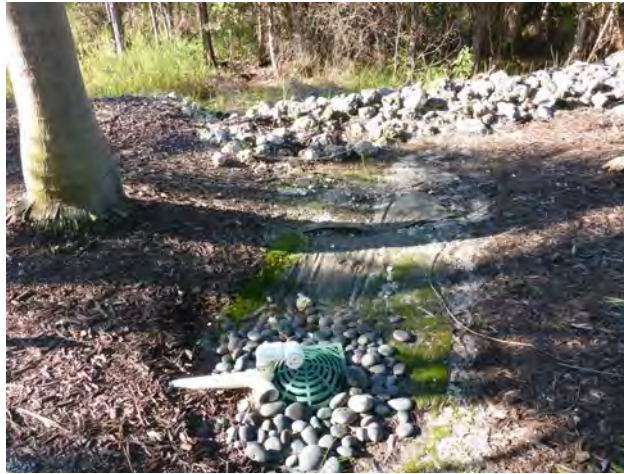
Picture 241 (P241)

Berm is eroded and potentially breached.

Restore berm with geotextile and rip-rap.

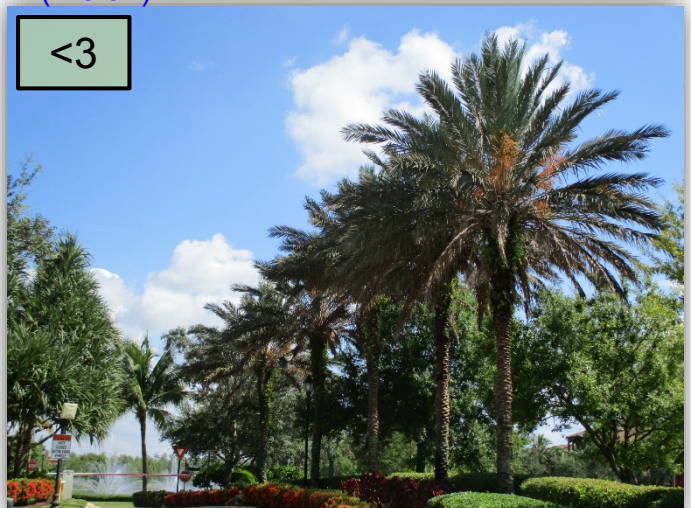
3. Noted last month, several Medjool Palms have developing fruit (that is dropping and staining) but also have a lower ring of dead fronds that should be removed. (Pic 3>)
4. Should we apply a specialty fertilizer to reverse the chlorosis (yellowing) of the Ixora? This plant is an acid lover and many times soil from roadway bases is very alkaline. (Pic 4>)

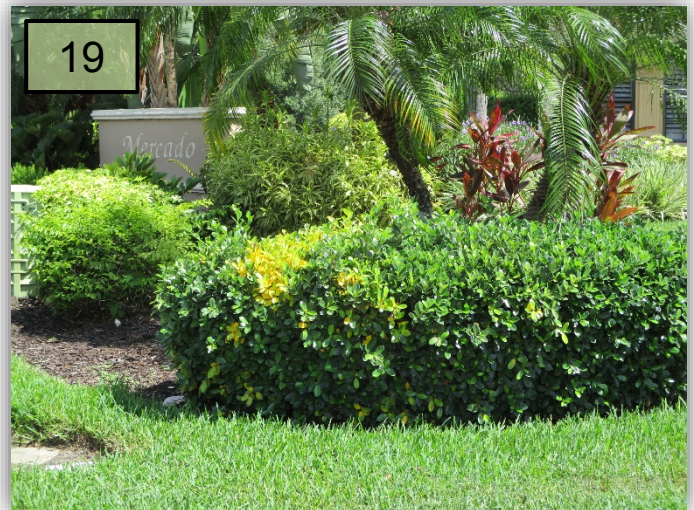
19. What is causing the yellowing of what I think is Green Island Ficus at Mercado? (Pic 19)

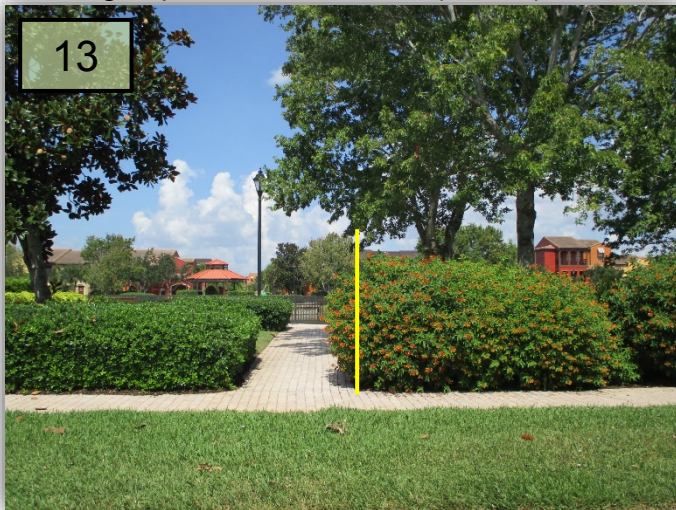
13. Make sure that at all gazebo entrances on the promenade, shrubs (mostly Dw. Firebush) are being kept off the sidewalk. (Pic 13)

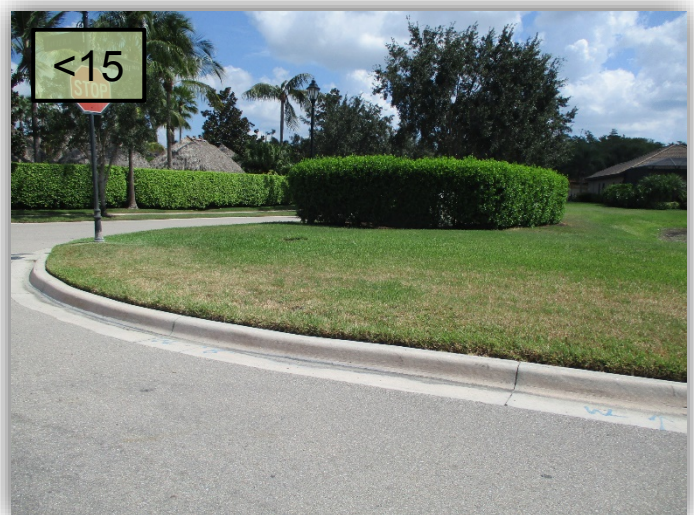
15. There are more dry patches in the turf NW of the east roundabout at Olinda. Additionally, there are more at Paseo Grande east at Javiera. (Pic 15>)

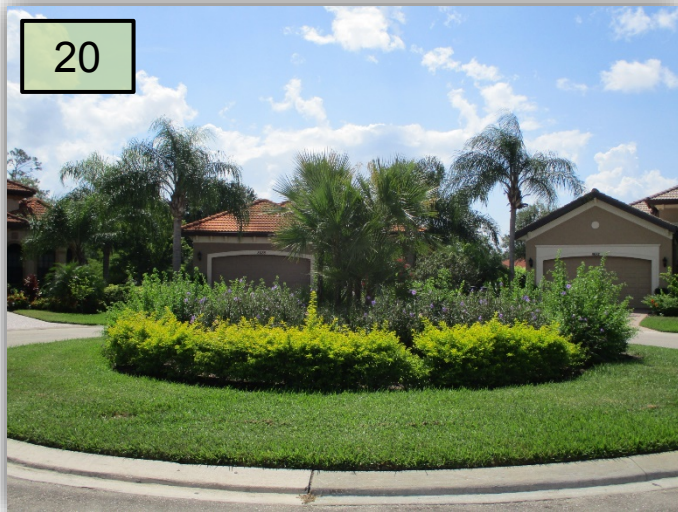
20. Plants on the Mercado cul-de-sac are way overgrown. (Pic 20)

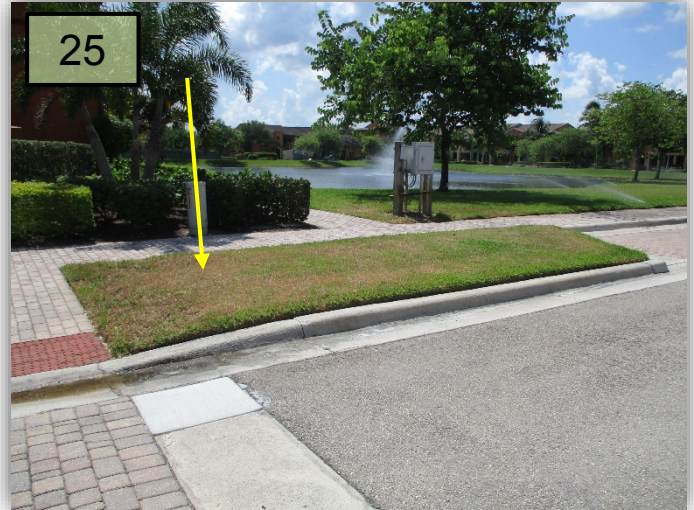
25. A large patch of extremely dry turf is at the intersection of Adoncia and Emelia on the east side of Adoncia. Is there an irrigation zone down? Rotors were irrigating at this time between the sidewalk and the pond, but not this area. One of the rotors running is actually spraying into the street. (Pic 25)

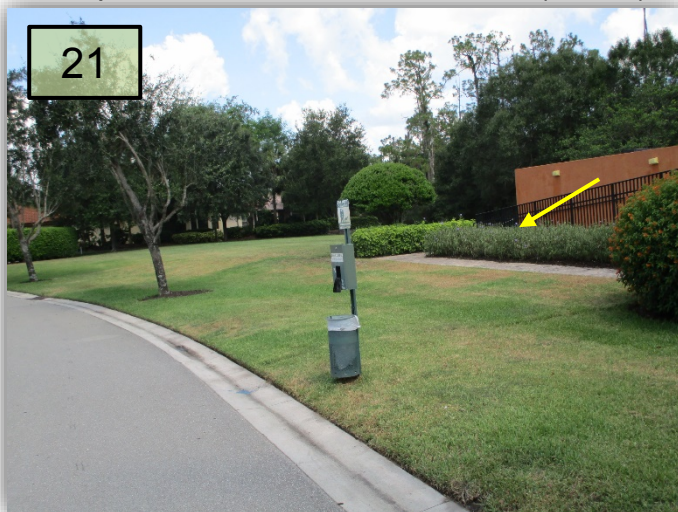
21. Turf between the dumpster area and lift station also appears very dry, but also the Mexican Petunia adjacent to the dumpster ramp is in moderate to severe wilt. (Pic 21)

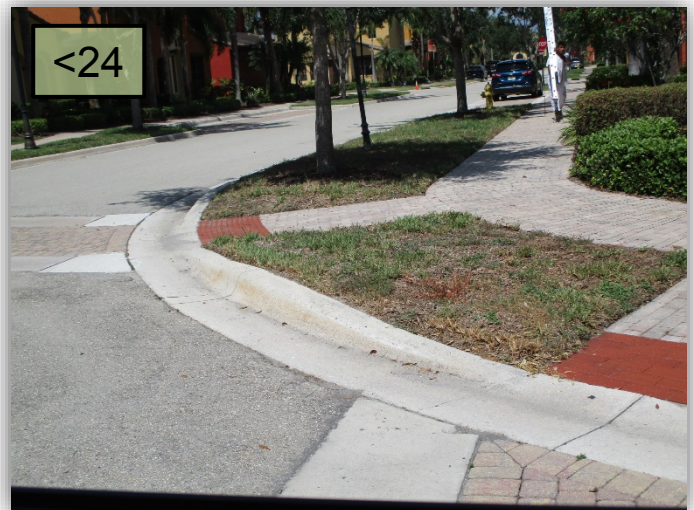
24. Turf is also bad in many of the street ROW's in the areas west of the main entrance, however, there is also construction in this area and it is difficult to pin this on maintenance practices. (Pic 24>)

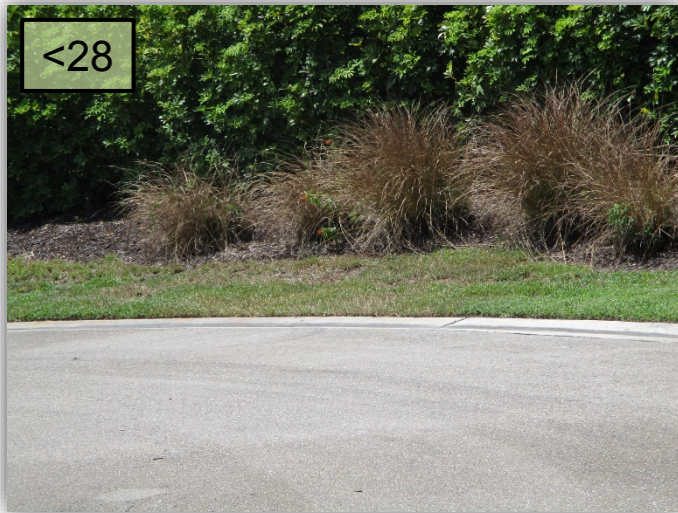
33. More Fakahatchee Grasses appear to be infested with Spider mite approaching Esteban south from the west. Drench and cut to a low mound. Also dead growth from Ginger needs to be removed. (Pic 33>)

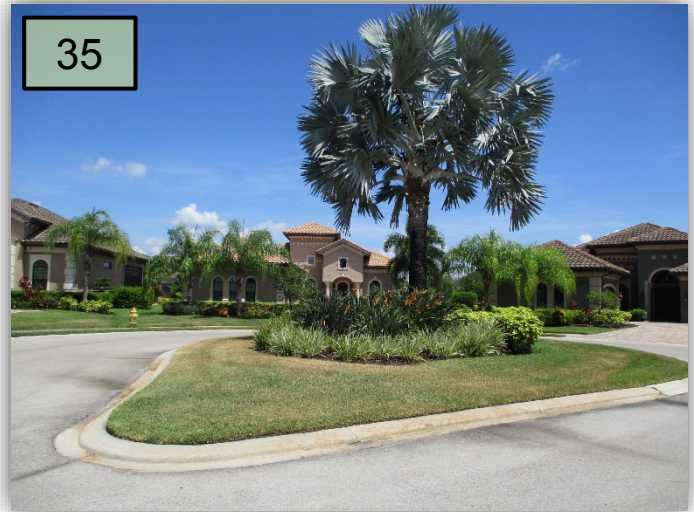
35. Turf on Macario Ct. is also extremely dry. (Pic 35)
